Ford C-Max Flat Towing Brake Lock-up update May 2018

By Mike Angles / mangles@pacbell.net

Written for current and future Ford C-Max toad owners, as a collective update for avoiding brake lockups.

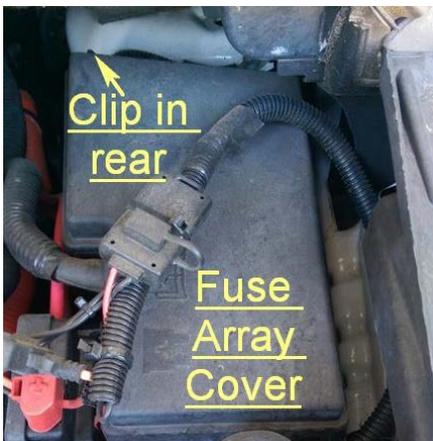
The photo on the left shows the main fuse bank cover as viewed while standing in front of the driver's side headlight looking towards the steering wheel. This photo also shows a [Hopkins 39332 BrakeBuddy Towed Vehicle Battery Maintainer](#) and wiring running across the top of the fuse bank cover. The BrakeBuddy charges the C-Max battery from the RV while flat towing to prevent a dead C-Max battery.

1. Reach to the rear left back-side (below the left edge) and you will feel the clip, which you cannot see. With your fingertips pull upward slowly in the center of the clip. The clip is about 1" wide, side-to-side. You will feel the clip lift up as it unlatches the cover.
2. Continue to lift the rear cover a few inches to clear the back of the fuse array base. As you do so the front will rotate freeing the front clips so that you can slip the cover forward an inch or so.
3. Then you just have to work the cover up and out of the way.

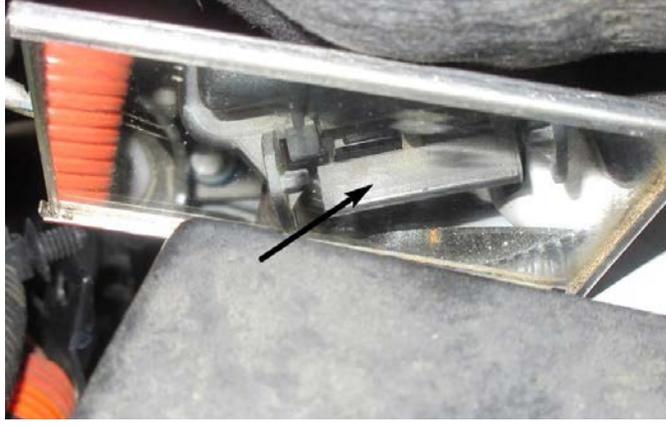
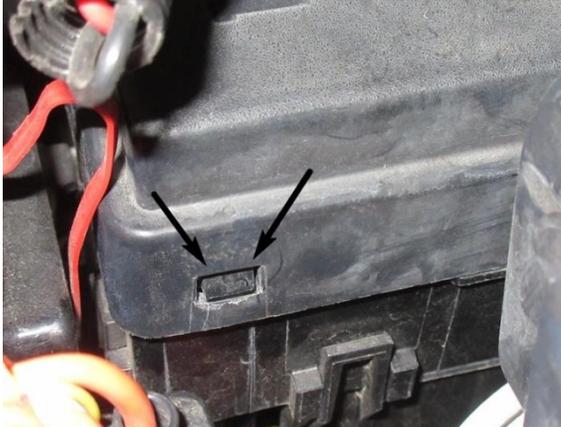
<p>Rear Clip: First locate the rear left corner clip as seen in a mirror. Lift this flat piece of plastic with your fingertips to release the cover catch. Very little pressure is needed to release the clip.</p>	<p>Front clips: The front has two clips, one on the left and one on the right that release as you lift the rear of the cover. Next you will work the cover out of the way to expose the fuse bank.</p>

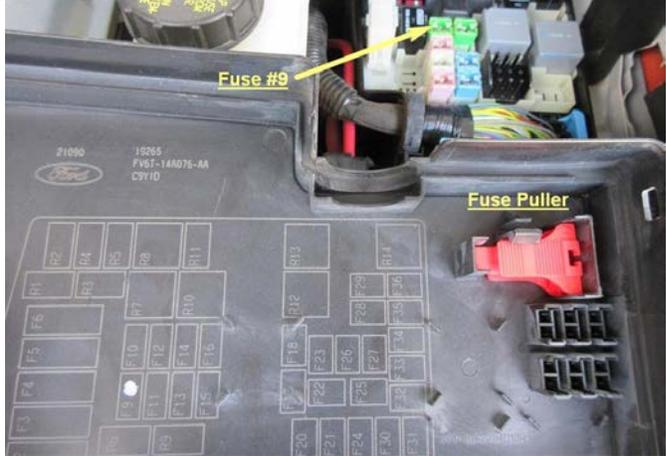
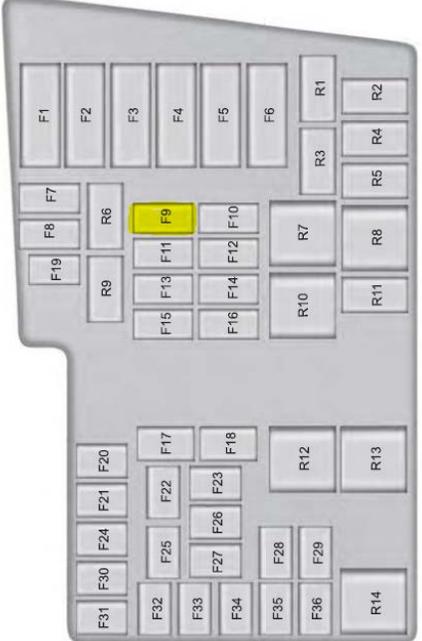
<p>A fuse layout and red fuse puller is located on the inside of the cover. The fuse puller works somewhat with ample fingertip pressure. In my car I have marked the Fuse #9 location on the inside cover layout with a white marker. The fuse cover layout is offset 90 degrees from the fuse bank.</p>	<p>C-Max owner's manual fuse layout aligned with the fuse bank orientation. Fuse #9 is highlighted in yellow and should not be confused with relay #9 (R9).</p>

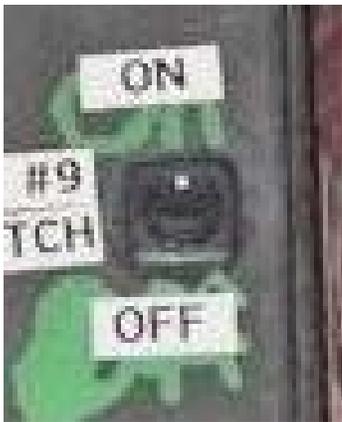
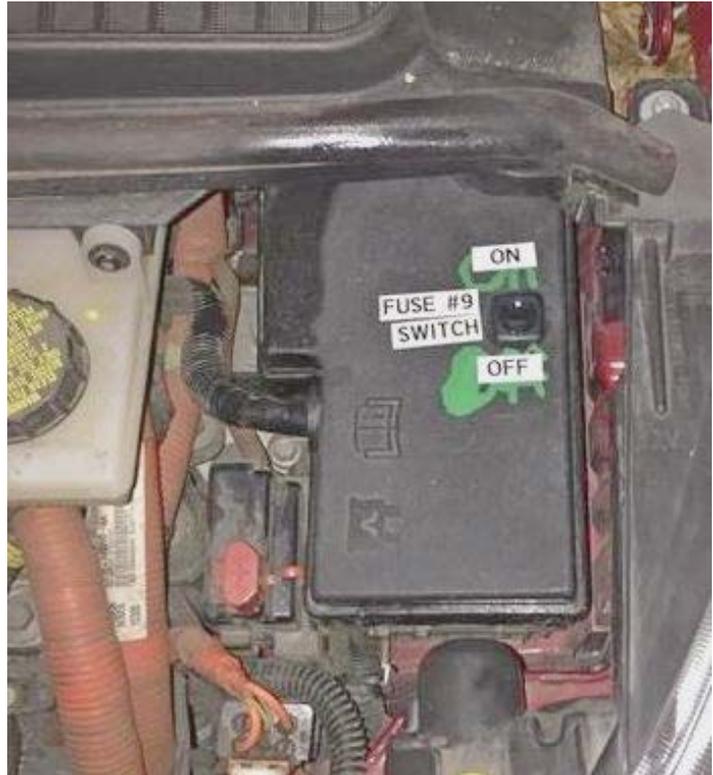
This solution was installed by a [ReadyBrake](#) installer for Chris P. It is a NSA RV Products “de-Fuser”. \$65.95 on the [ReadyBrake](#) web store and a little less at [RVupgrades.com](#)

In researching such a solution, I found 12 VDC rated 50 amp switches on Amazon with long switch paddles. However, in looking at this ReadyBrake solution, I was impressed by the use of a low profile rocker switch and the small size that allowed the installer to place it within the fuse cover.

This appears to be a simple solution in which using a good switch and water leakage protection are important.

We have learned the C-Max electric vacuum pump is protected by a 40 amp fuse. In my opinion, I would **NOT** use a by-pass solution with a smaller amperage rating as wiring, or the switch that is normally in the closed mode for non-flat towing could fail.

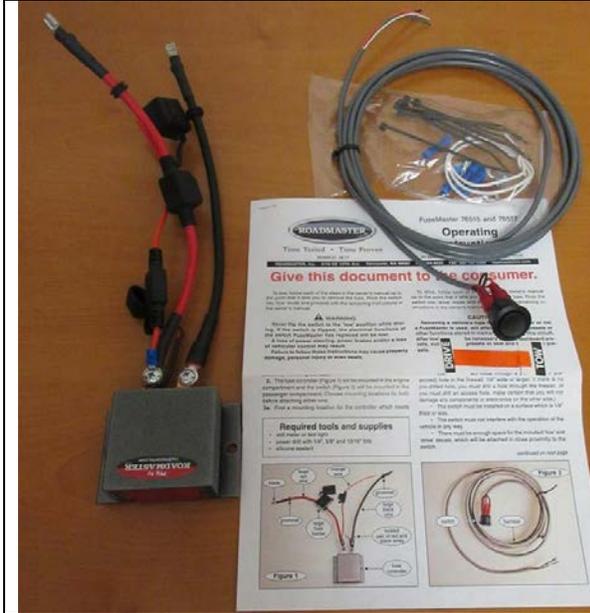
RoadMaster JK76517 kit with instructions.
Available from eTrailer.com or RoadMaster.

The following photos provided by Joel P. show the RoadMaster JK76517 installed on his Energi. The RoadMaster kit provides a small switch in the driver’s area for easy use. This switch controls an engine compartment located heavy duty latching relay housed in a heat sink. Note that the switch that comes

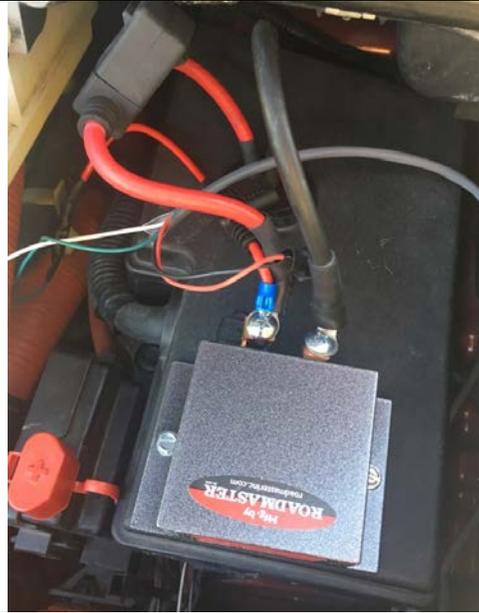
Heat sink mounted relay installed on the fuse cover. Note heavy gauge wiring and fuse. High amperage stays under the hood. Small gauge wiring is for remote switch in driver's area.

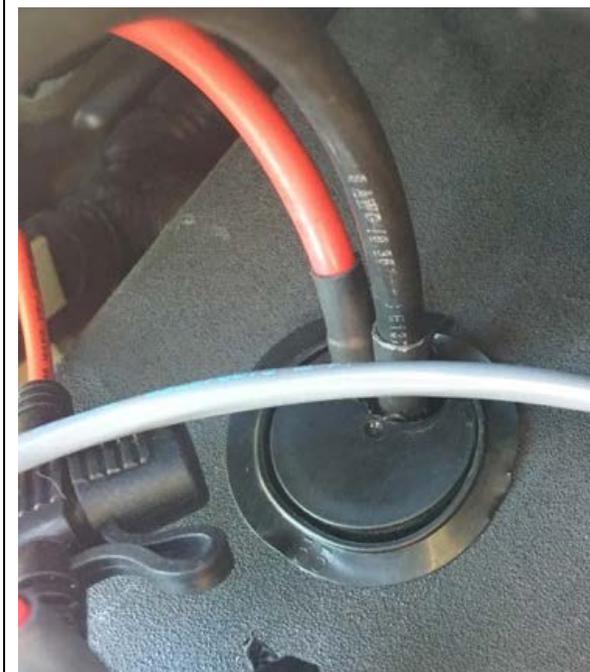
Close-up photo showing wiring penetration in the fuse box cover from the RoadMaster relay to Fuse #9 socket under the fuse cover.

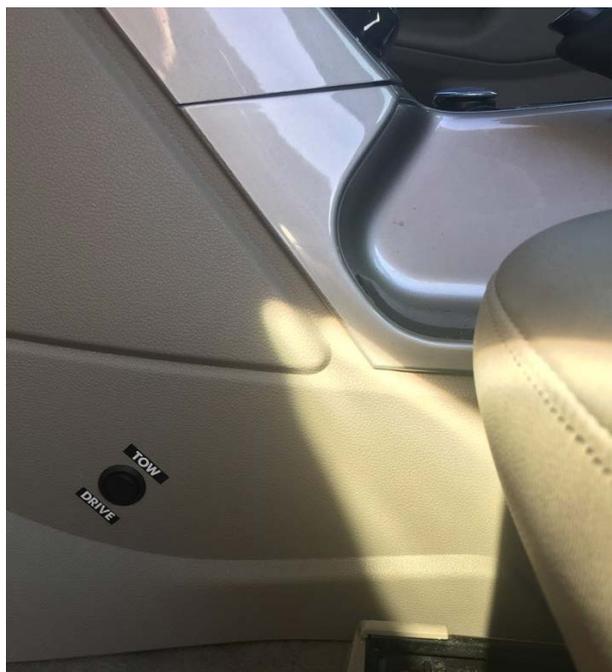
Driver's compartment switch mounted in the side of center console between the driver's seat and gas pedal.

with this kit does not click to each position, but is a momentary rocker switch without any indicator light to show that it is in towing or non-towing state. That is an enhancement that would improve this installation.

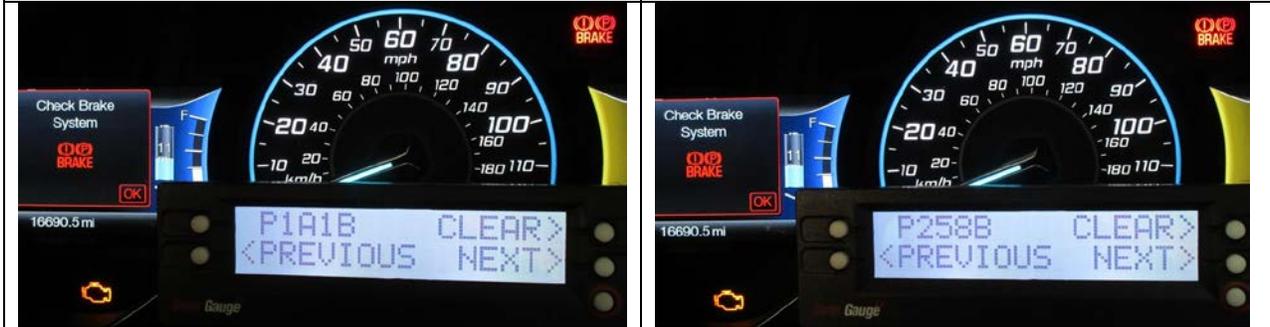
The dashboard "engine service alert" and other brake system notifications were displayed as shown in the following pictures. DTCs P1A1B and P258B were observed on a ScanGauge. Both DTCs were cleared automatically after reinstating Fuse #9, and 3 or 4 car restarts.

P1A1B - Per the Ford OBD manual: **Brake System Control Module** - Forced Engine Running by request of Brake System Control Module due to regenerative braking system fault.

P258B – Per the Ford OBD manual: **Brake Vacuum Pump General Electrical Failure** - Vacuum pump control circuits are used to activate and control the electric vacuum pump to provide the required amount of vacuum to the ACU. Diagnostics on these control circuits include general electrical faults such as short to ground or open circuit (general electrical fault).

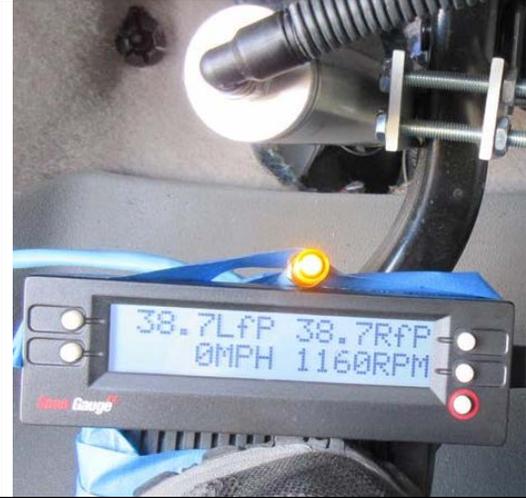
While flat towing, the LED showed normal vacuum pump activation with the ignition on and sometimes with accessory mode on. Furthermore, I observed the LED flashed on for milliseconds in my car while towing with the ignition off.

LED indicator testing in my C-Max before a towing test. The LED shows electric vacuum pump activation.

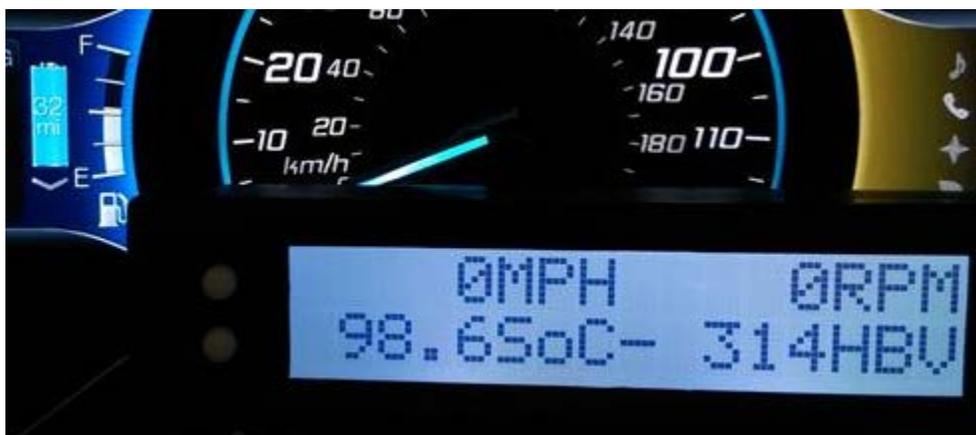
And I learned that even with the ignition off and no incremental odometer mileage, at the end of a day of towing, the Energi's "big battery" display showed a full charge (I believe from regen braking) and the display showed a PHEV mileage range exceeding Ford's 22+/- miles specifications. That is, the maximum range for PHEV travel is about 22 miles with a fully charged PHEV battery. Yet my C-Max erroneously would display a higher range, up to 38 miles.

Below is a photo showing 32 PHEV mile range on the left. And my ScanGauge shows the PHEV (big battery) with a 98.6% State of Charge (SoC).

I once spoke to our local Santa Clara Ford dealer about this. He felt the PHEV computer was tracking the flat towing mileage as if the car was driven on electrics and incorporating each day of flat towing into its counters increasing the average value of the PHEV display. And this was while flat towing with the
