On July 1st, 2014, my wife and I took delivery of a new 2014 Phaeton QBH. Our purchase was delayed from May 2014 while the dealer repaired chipped tiles in the rear bathroom around the engine cover hatch. As of September 1st, 2014, we had yet to take our maiden trip due to family commitments and as we continued “outfitting” and correcting concerns with our new coach.

This is a collection of observations, concerns and enhancements since the July 1st delivery. I am writing this for my records, and to send to our dealer and Tiffin. Additionally I will post a copy on the Tiffin RV Network (TRVN) web site at <http://www.tiffinrvnetwork.com> as this information may be useful to others. My thanks to the wonderful TRVN members for their countless ideas and information. Your knowledge sharing greatly aided our new ownership learning curve. While we expected to incur new rig issues, I have been surprised by the amount of time required to prepare our land yacht for launch. I am also pleased that the issues we have encountered are rather benign.

Note: Since I did not publish this paper before our Sept 9th trip, I have added an additional section at the end of this paper entitled Updates and

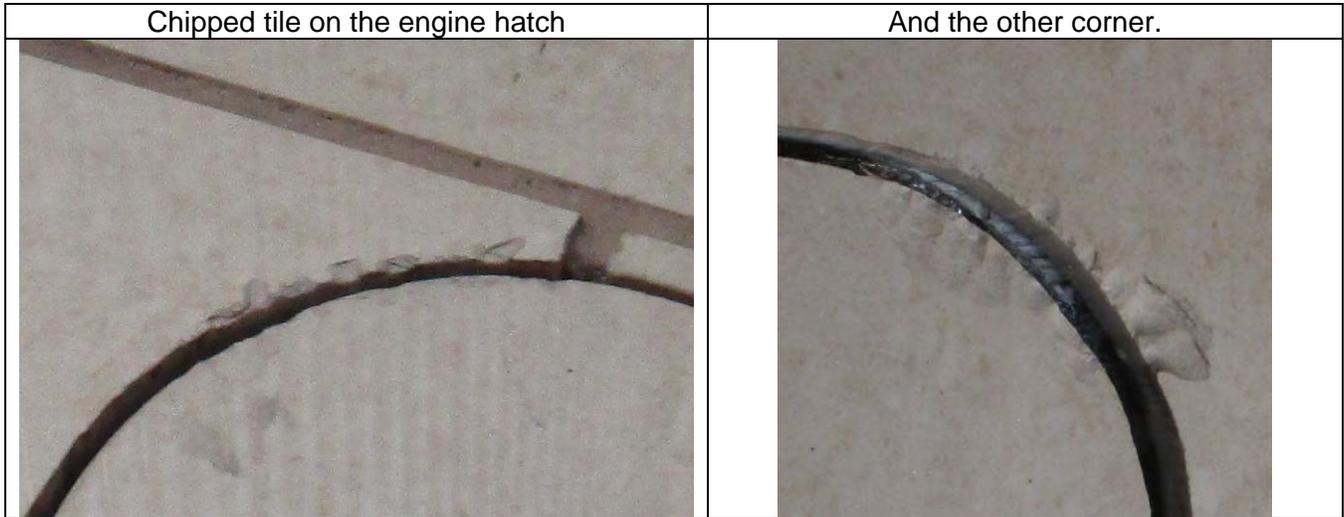
As I noted in the introduction, our delivery was delayed by bathroom tile repairs. It is my belief someone lacking the tools and procedural knowledge needed to gain access to the top of the engine via the hatch in the bathroom. In speaking to the dealer, Tiffin Hqs, and the Tiffin factory rep, I was advised there is no record of such access. Not knowing why something occurred, concerns me more than believing there was a problem that required correction.

Post tile repair photos

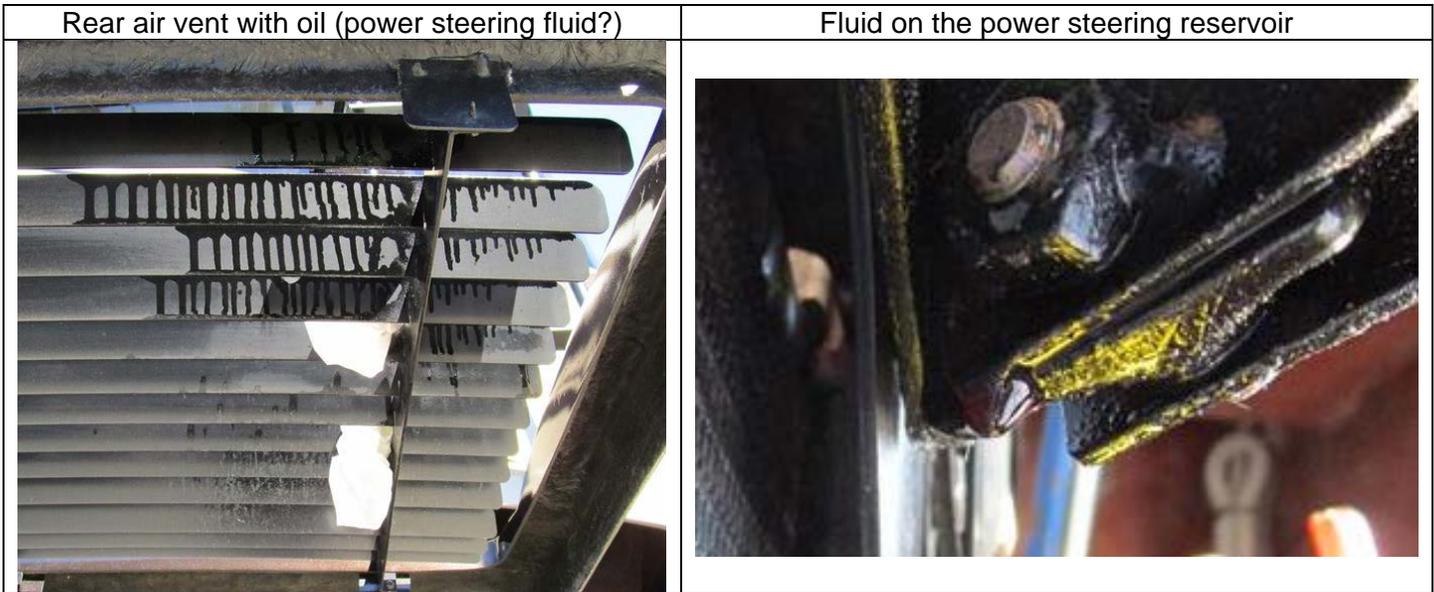
While driving home with our new purchase, I smelled something burning within about 15 miles of leaving the dealership. The odor was strong enough that I pulled over onto the emergency parking strip and checked the rear engine area and tires. There was no visible evidence of a problem. We arrived home some 60 freeway miles later, and I noted a small amount of fluid running down the inside of the rear engine cover and pooling on the bottom of the right side of the radiator and on the bumper. Additionally the paint had lifted partway down on the radiator.

The following photos show “fluid” running down the rear air vents and dripping from the power steering storage reservoir. The color and texture of the fluid is consistent with power steering fluid. The reservoir level is at the minimum cold level and the dip stick indicates a need for additional fluid. I know there were no visible leaks when we conducted our pickup inspection at the dealer, but they had just washed the RV prior to our arrival.

We also found the power steering reservoir leak that I noticed within the first 15 miles of ownership. I still don't know how Happy Daze RV could have transported this coach between Sacramento and Livermore, and to a RV show(s) without it leaking.

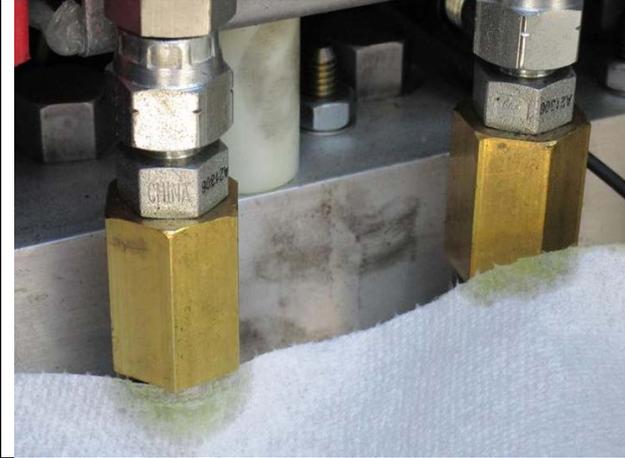
After reaching home I parked the Phaeton in front of our home and used the automatic leveler system. A few days later I noticed that the extended driver’s side-out was a few inches low, and there was a wet area under the propane/hydraulic compartment. I inspected the hydraulic leveling system and found oil on the compartment floor and under the oil tank. A fluid check showed no oil on the dip stick. I checked all the connections and found oil on each of the manifold elbows below the brass velocity valves (see picture below). A call to the dealer indicated they had checked the leveling system during their PDI and found no issues. I called HWH technical support and they advised that the fittings required a Teflon tape wrap to stop the leaks.

Small leaks add up under pressure (DS lines).
The passenger side (PS) leaked just as much.

A week later, after ordering and receiving four quarts of replacement HWH hydraulic fluid from Amazon, I started the repairs. I disconnected and inspected each line and fitting at the manifold. It was obvious to me that the brass velocity valves were bottomed-out into the steel elbows, but not checked for leaks. The HWH system produces 3,000 PSI of hydraulic pressure, which is enough pressure to force oil between imperfect metal surfaces. I wrapped the threads with Teflon tape per HWH instructions and conducted new sink tests. The initial tests were disappointing, probably because of air in the lines. However, within a week, I went from 3/8” of driver-side sinkage in a 24 hour period (with only the driver-side slides extended) to less than 1/16”.

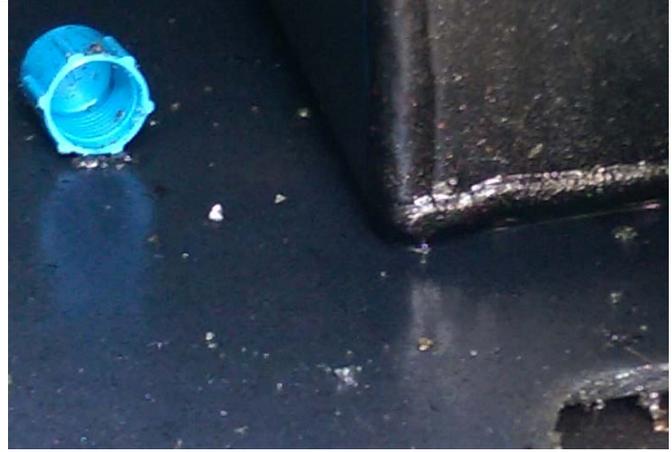
Oil-covered floor around the HWH tank.

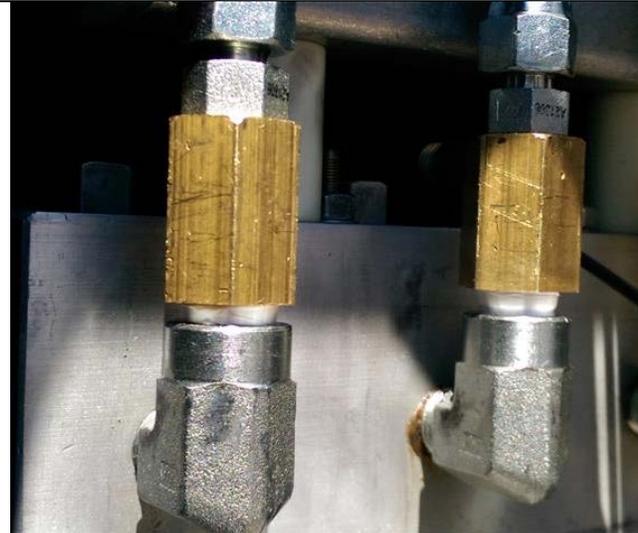
DS connections with Teflon tape.

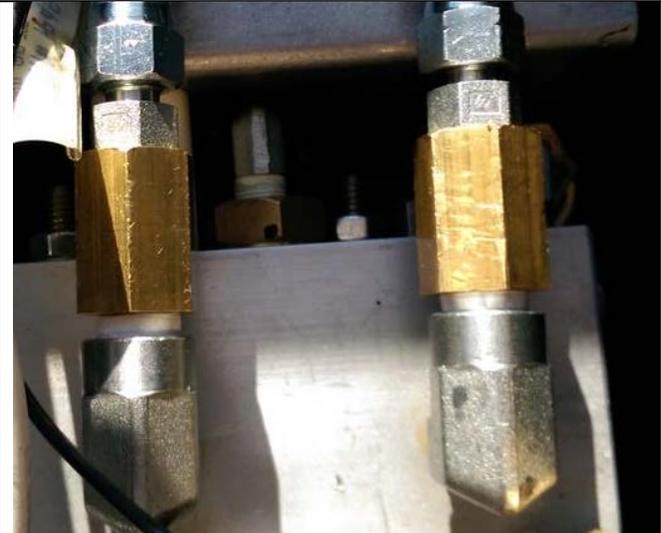
PS connections with Teflon tape.

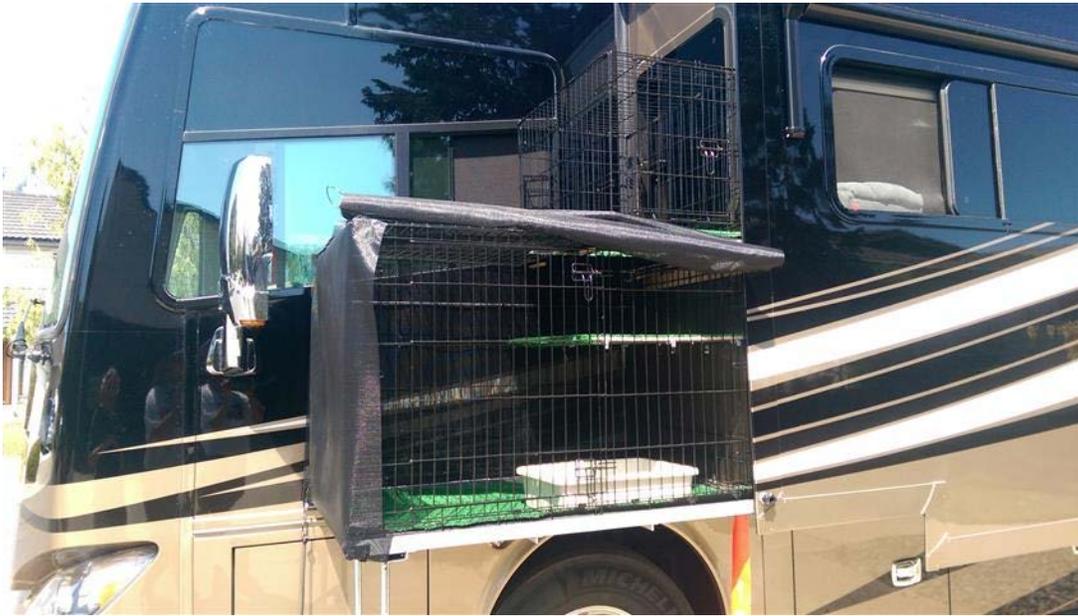
This photo shows the completed multi-story condo. I custom-cut pet screen covers for both cages to filter direct sunlight and provide a little “privy-cy” for our eating-and-pooping machines.

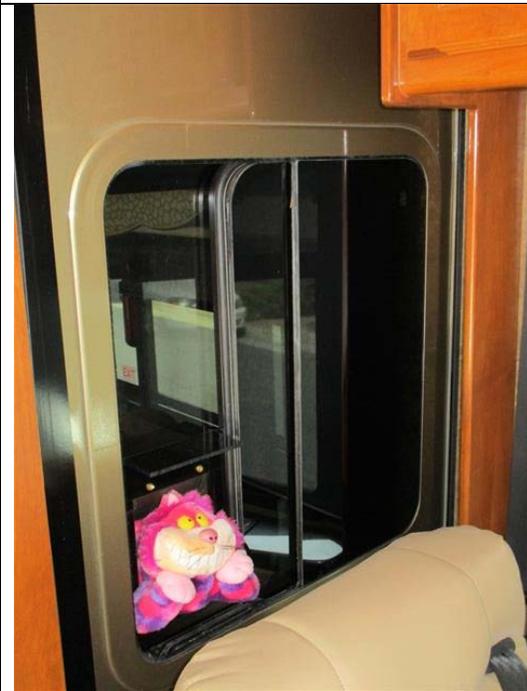
Inside view with the slide-out in. Here I built a custom cat shelf which is supported by two sisal-wrapped ABS scratching posts.

Outside view of the pet door (with the slide-out in). Note the Tiffin window is in the open position and the screen is removed. The smoked cat door insert matches the Phaeton windows.

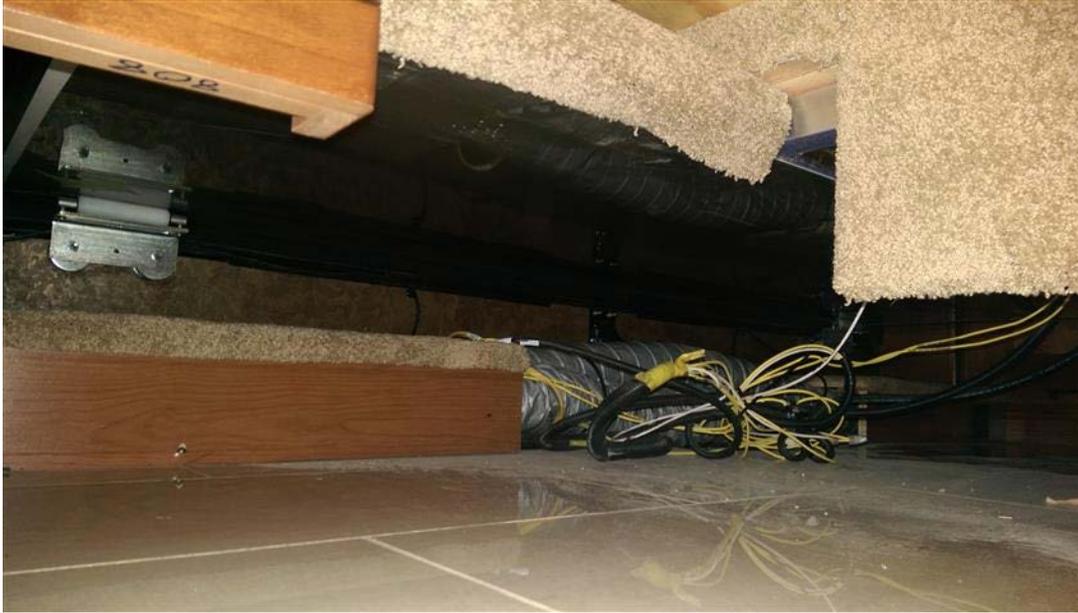
Here's the under-bed area showing heater ducts and wiring as seen from the left (rear of the rig). As an engineer, I would be embarrassed to leave such an exposed rat's nest of unsecured wiring.

While my solution did not clean up the wiring (a future project), the addition of wood panels prevents pet access to this space while allowing the bed slide-out to slip freely. The added wood panel is attached to the stationary platform, not the bed platform.

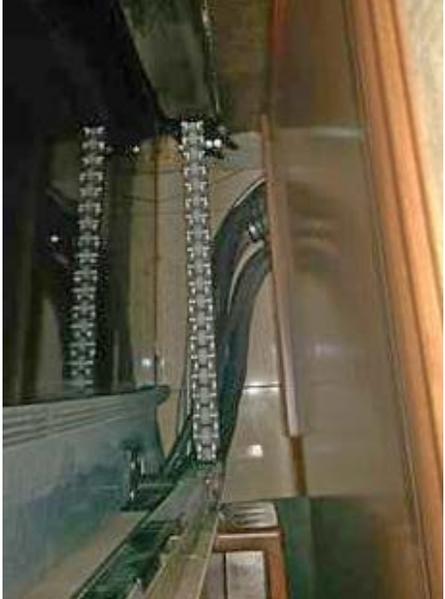
Before:

Kitchen slide-out bottom adjacent to half-bath. A natural pet tunnel to explore.	Crush area! There is no easy way to extract a pet from this space.

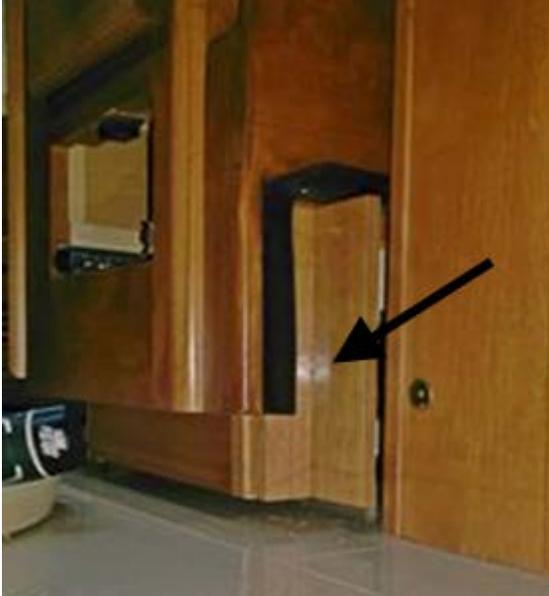
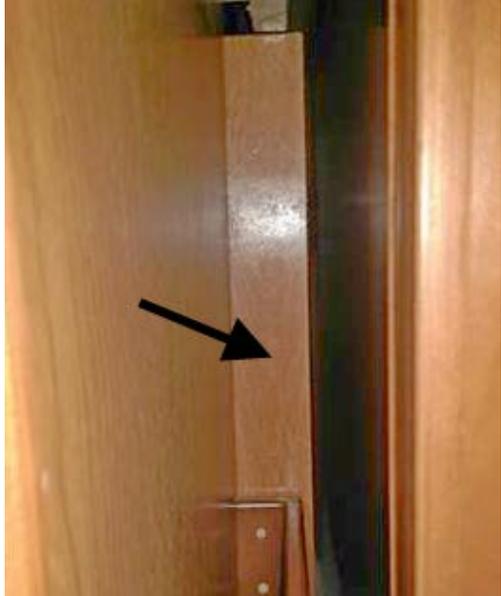
After:

Cave access closed with the addition of a simple wood insert. Wood screws allow easy removal if needed for maintenance.	Another wood addition at the cabinet rear prevents access into the chain area.

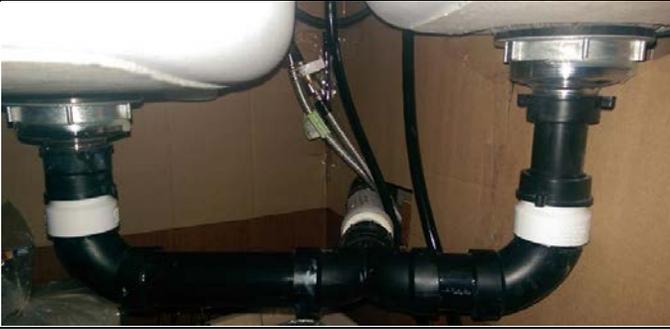
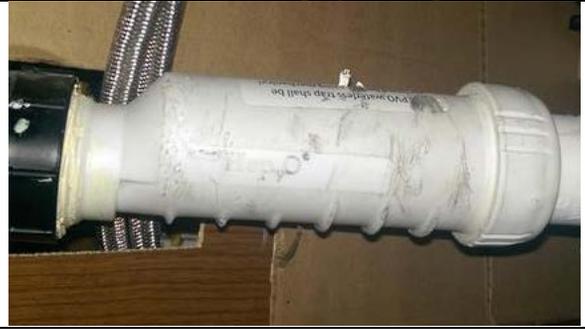
Cardboard pet-proofing under the kitchen sink area at the rear. Note the use of a HepvO sanitary waterless trap (white pipe at the back center of the picture).

Close-up view of the kitchen HepvO sanitary waterless traps. These devices eliminate the need to add water to sink traps to stop holding tank smells from coming up through the sinks.

Additionally, I installed some cardboard under the kitchen sink, where large cabinet openings at the back could also prove inviting to our feline companions. The use of cardboard ensures easy removal if I need access to the rear of the outside TV or the kitchen slide-out connections.

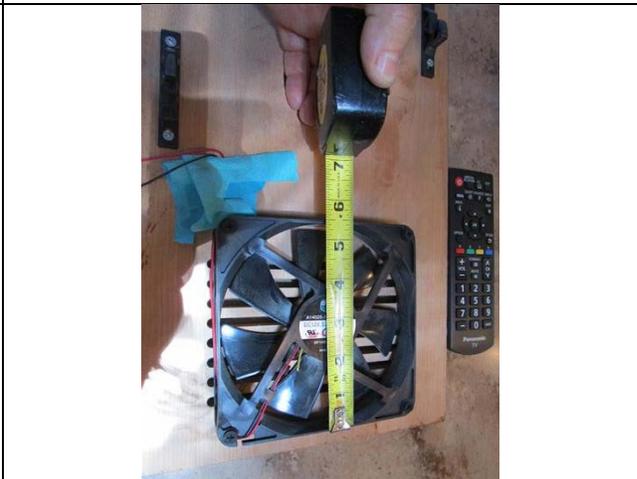
Bedroom TV equipment cabinet. DirecTV receiver pulled out shows lots of wires. The enclosed HDMI adapters are behind the wood cover on the right with the vent cuts.

The 12 volt fan in an enclosed space created too much noise. Restricted grill slots reduce efficiency.

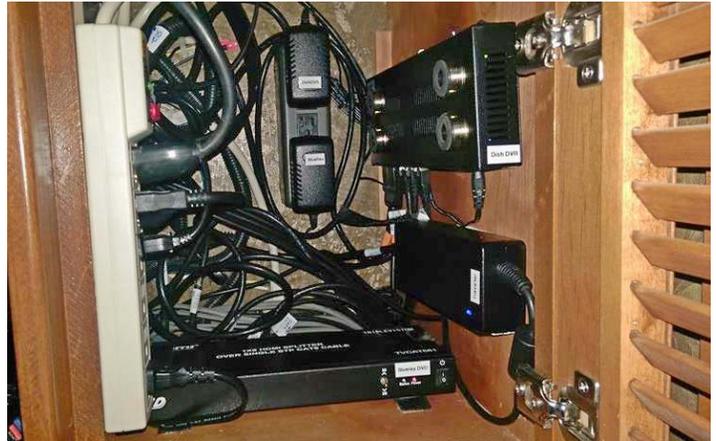
Updated HDMI space using the cabinets as heat sinks. Note addition of switchable power strips and Trav'ler power supply. The power strips allows us to turn off the TV equipment when not needed.

I removed some of the wood trim to reduce the heat build-up. This allowed me to reposition the HDMI adapters and add a Trav'ler ac adapter. I mounted each adapter separately as far apart as I could so that the wood cabinet would act as a heat sink. Next, I added power strips to turn the TV equipment on and off with one switch when not in use. Temperature measurements show the HDMI adapters cooler than before, but still warmer than I prefer. However, the air temperature in this small cavity is at room levels without the noisy fan. If I need to, I can later add a quiet ac-powered fan or metal heat sinks to the HDMI adapters.

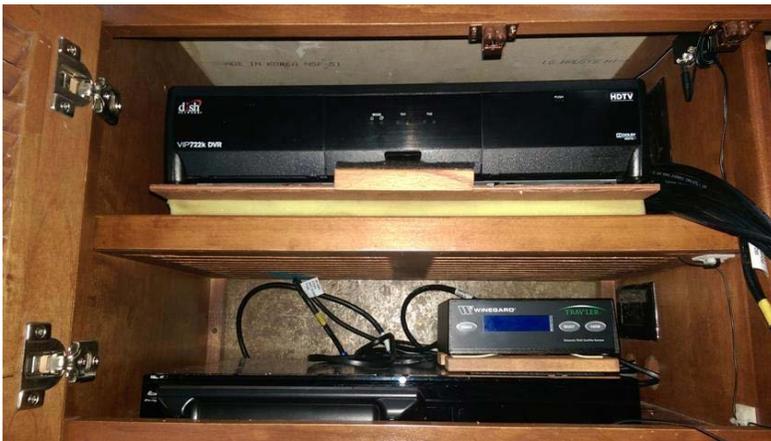
In this first photo, you can see the 1" yellow-green foam rubber below the plywood supporting the DVR. The top layer of plywood extends 1.5" beyond the front of the Tiffin shelf. The DVR rests on the plywood, not the foam, to allow air to enter the bottom DVR vents for cooling.

While making these changes, I also removed the Tiffin-supplied DirecTV receiver and adapted the area for our Dish DVR, which won't fit on the too-shallow Tiffin cabinet shelf. I built an insert consisting of two pieces of plywood separated by form rubber. The top piece of the insert is almost 2" longer in the front than the bottom, allowing the Dish DVR to extend further forward than the Tiffin shelf but still fit behind the cabinet door. This offset also has the added benefit of providing about 2" of wiring and cooling space at the rear of the DVR.

In designing this insert, I wanted a solution that protected the DVR from road shocks while we traveled. For me, turning off the DVR so that the disk-drive heads are parked is not good enough. The form rubber creates a padded platform in the cabinet for vertical cushioning while also reducing lateral movements. I call this solution a "DVR bed". Here are some photos:

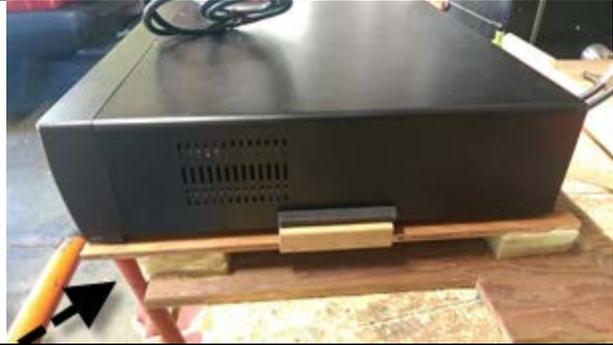
Side view of DVR bed. Here you can see the top section's front extension on the left and the foam rubber supports. Two strips are used to provide a soft cushion to absorb road shocks.

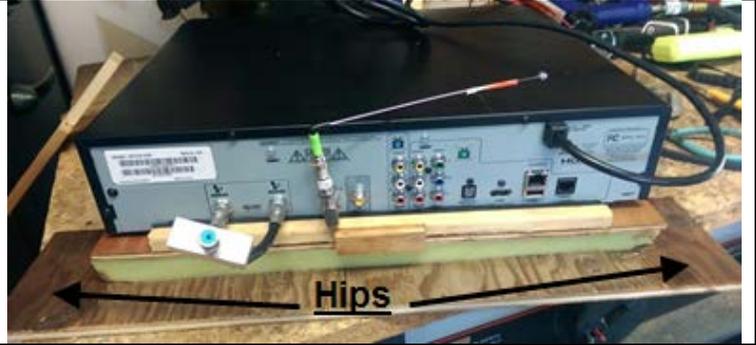
Rear view. The hips of the bottom plywood layer are sized to fit firmly in place between the rear cabinet corners. Form rubber weather stripping on the four sides provides lateral cushions.

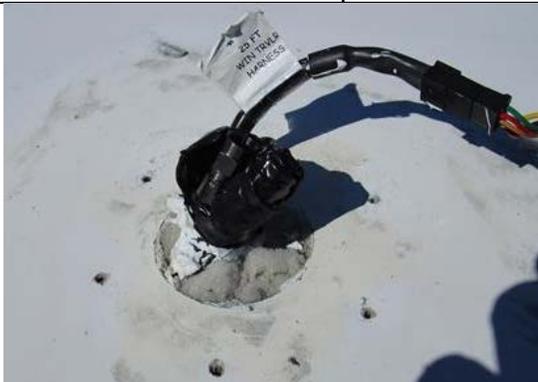
Tiffin-installed roof Trav'ler wiring after removal of the weatherproof domel.

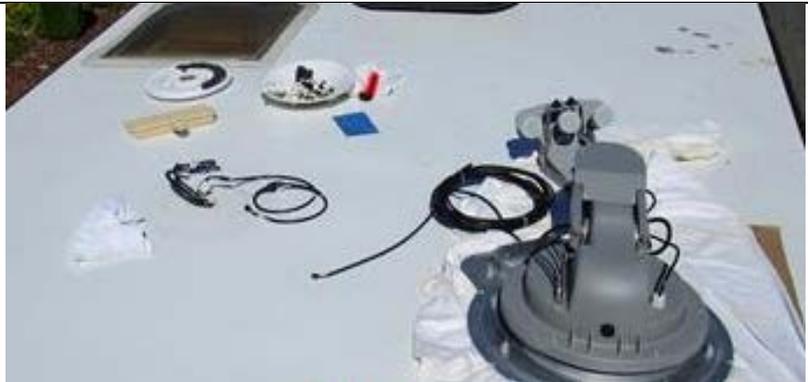
Trav'ler before installation.

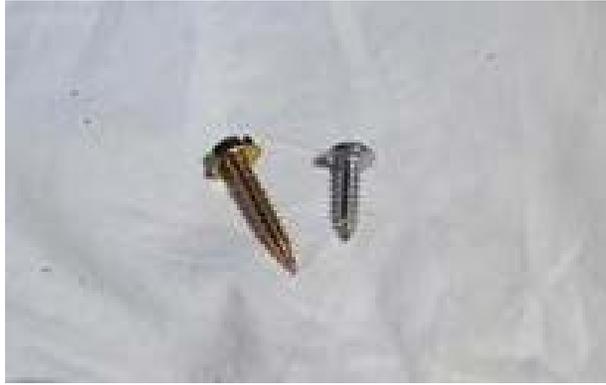
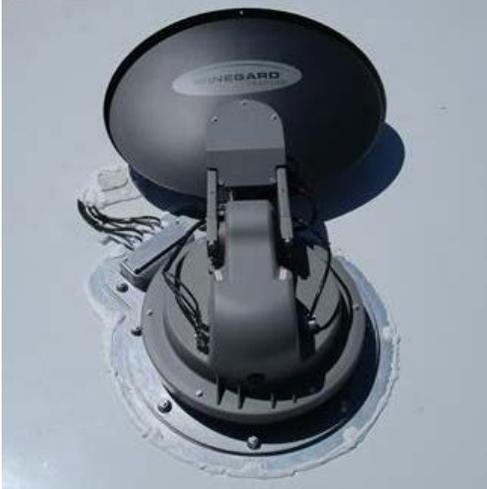
<p>Trav'ler provided screw (gold on the left) and my 5/8" stainless steel screws.</p>	<p>Finished installation. The Tiffin factory installed wiring made this project a breeze.</p>

Before installing the Trav'ler, I called Tiffin Service to get the locations of roof electrical ducts, and also to find out the correct length screws to use. I never did get an answer to any of my questions, which is my point in writing this paragraph. The nearest answer I obtained was "you better not use screws that are too long". In the end I selected screws based on what Tiffin had used by locating a screw in an upper roof channel. Additionally I used diagrams found on the TRVN web site. Thank you Crusingator (Ted).

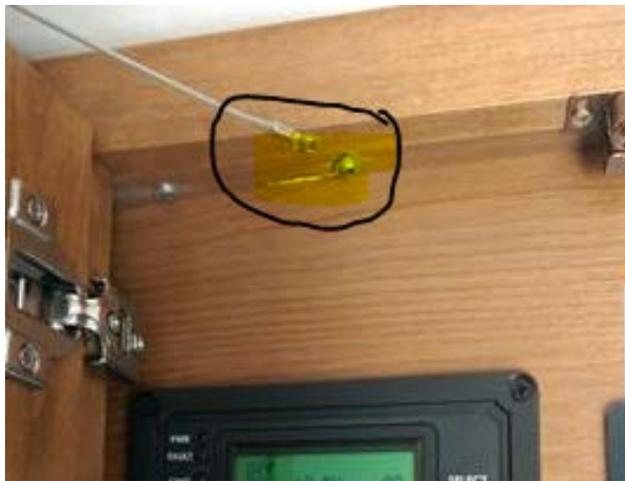
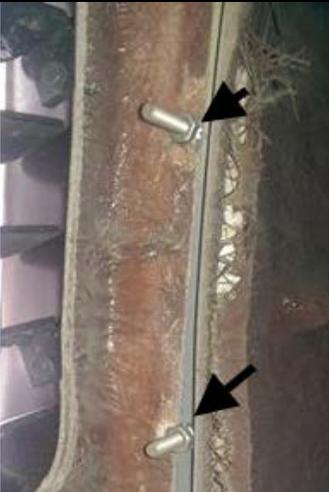
<p>DS electrical switch cabinet with AGS, etc. Toenailed screw crushed and split the wood. Reflective of impact drivers. This was also seen in other locations in the coach.</p>	<p>Rear bumper vent that is held to the corner sections with two bolts at each side. In this photo the DS bolts missed the center section. Right side bolts provide the support. I drilled new holes for the exiting screws to correct this before the rear grill broke off.</p>

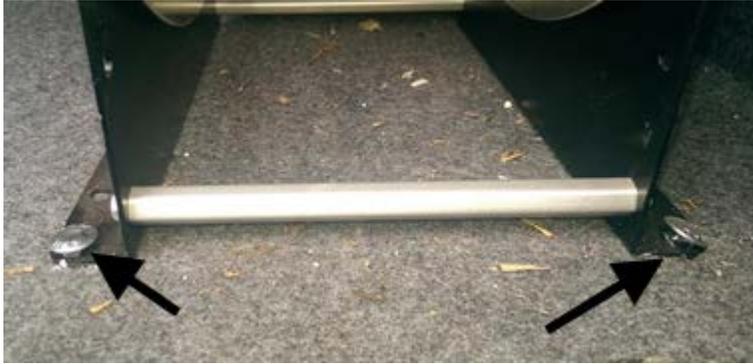
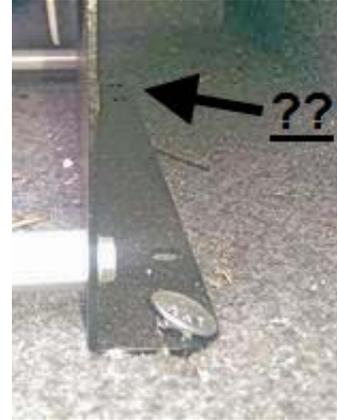
50 amp, shore cord power reel. Note use of carriage bolts.
 This is a case of placing a square bolt into a round hole.
 And even then the front right and left rear bolts missed the metal support railing under the floor.

As for the right side. I guess one wrong bolt was OK as the rear bolt was never installed. This omission places all the upward rewind pressure on the one incorrectly installed left rear carriage bolt. I will correct this in the future.

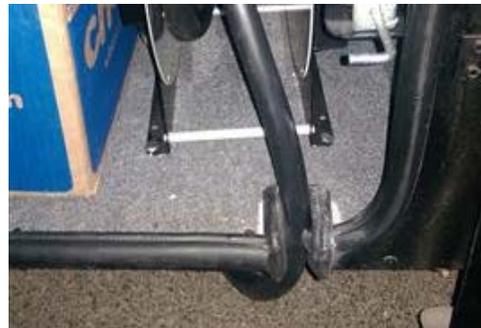
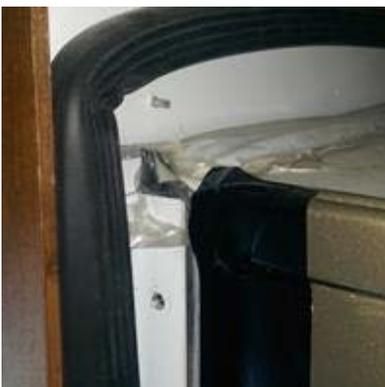
The reel assembly is not aligned true to the compartment (twisted), nor is it centered to the floor cord cutout.

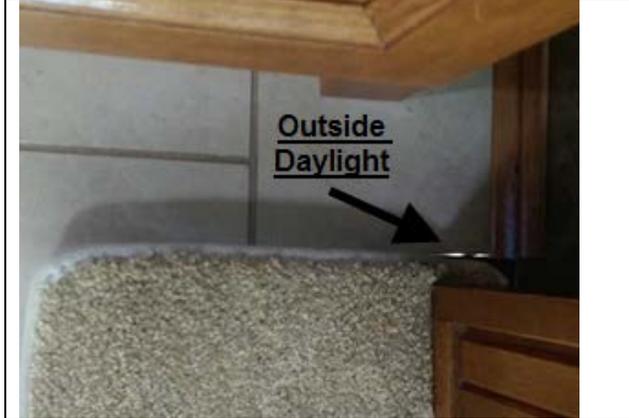
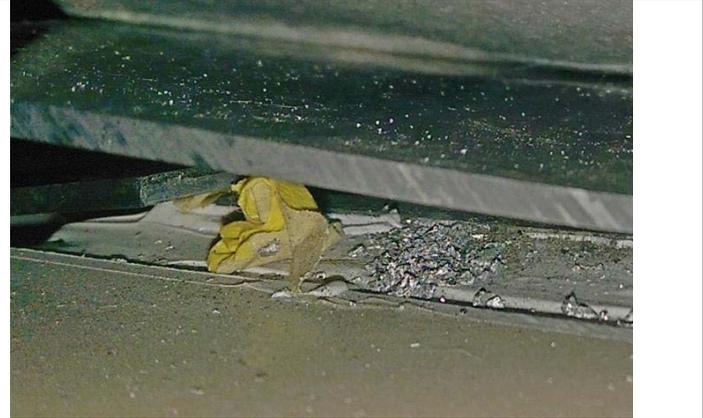
Missing front DS slide-out fastener. Also noted is thin clear plastic wrap or packaging tape on the upper edge of the slide-out. This is only viewable when the slide-out is retracted.

In this photo I lifted the carpet to find the light source and noticed debris including metal shavings that may be left over from manufacturing or due to slide-out metal damage. I cleaned up this debris.

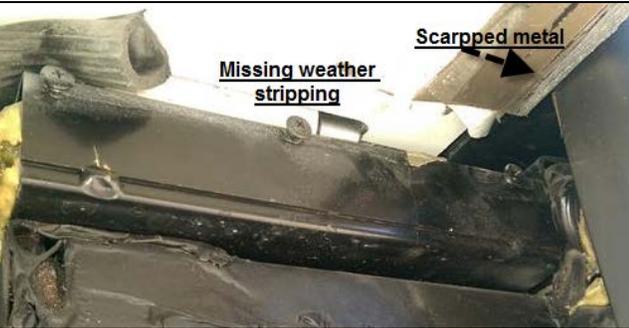
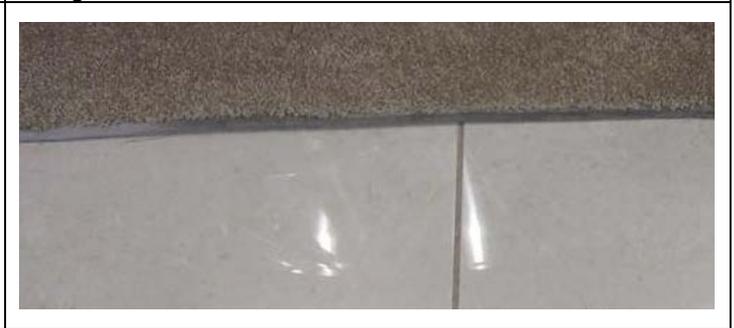
Outside edge of slide-out framing on RV, under the slide-out. 3 screws holding nothing imply something is missing.

Stained edge of carpet near the refrigerator. Was this stain caused by the slide-out gap that allowed outside elements inside? There is no evidence of a refrigerator water leak.

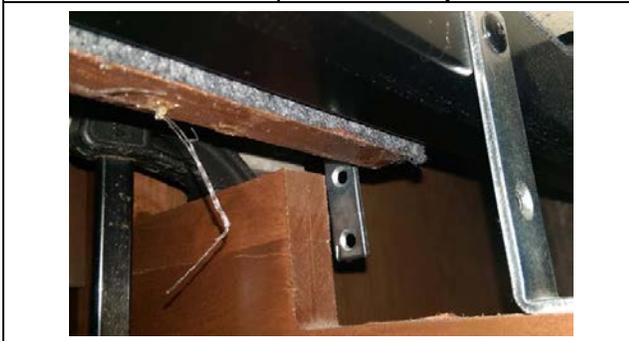
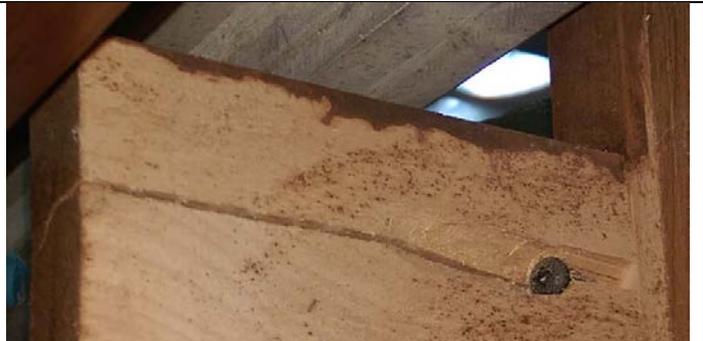
The L-bracket limit-stops under the extending dinette table are too short, causing too much pressure on the unreinforced soft wood cabinet face frame when the table is pulled out. Additionally the toenailed screws weakened or split the wood, which had already happened in our brand-new rig. This repair required just some glue and clamps. Later I will reinforce the face frame and install longer L-brackets with felt pads.

Photo showing the L- bracket under the table while repair underway.

The break location is in line with the bottom edge of the "L" bracket and the toenailed screw.

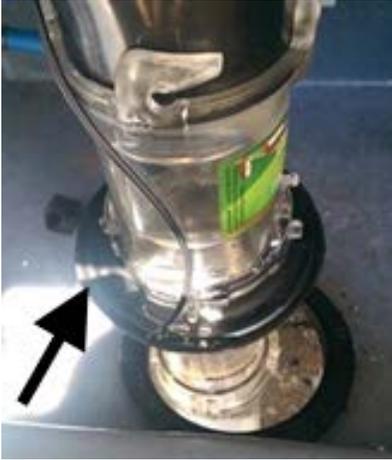
Tiffin has done a good job of sealing the basement from outside pests. One exposure point adjacent to the storage basement is the wet bay opening for the sewer hose. The hose can create a rodent highway. The sewer hose opening, if sized correctly, should allow easy hookups and also prevent unwanted entry. Getting it just right can be difficult due to the alignment of the various elements. This can also provide a quick gauge of workmanship.

Here is a photo showing the misaligned wet bay penetration with a dump pipe extension. Some RV'ers make a rodent barrier using foam rubber or cutting down a plumber's helper into a large rubber ring (as shown here by the arrow) that can fit into the gap. Unfortunately, the misalignment does not allow for such a solution in my RV. As an alternative, I custom-made a two-piece fiberglass plate that wraps around the drain hose or extension inside the basement.

The wet bay access plate is secured with excessively long self-tapping screws that will easily destroy drain hoses. This is an example of poor end-user engineering as sewer hoses are a thin wall vinyl. I will correct this with correctly sized stainless steel screws and locking nuts.

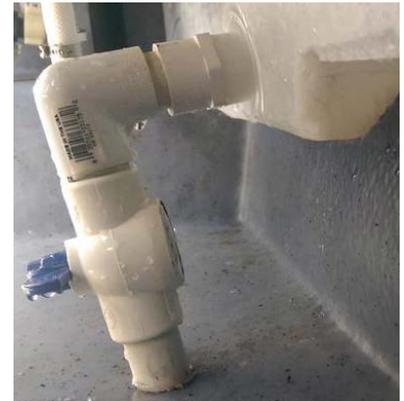
Another wet bay item that caught my attention is the angle of the fresh water tank drain pipe. It appears to be creating a stress point at the tank connection point; that with time could fracture the water tank. I need to investigate this with Tiffin to determine if there is a design reason.

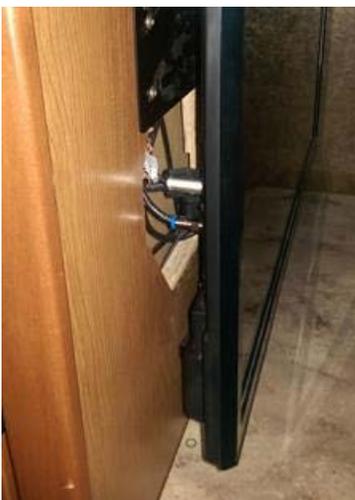
Panel opening for TV cables at the mid-TV set adjacent to the refrigerator. A rather oversized and unspecific hole cut to accumulate a few cables. A smaller opening and/or some wood trim would have made all the difference.

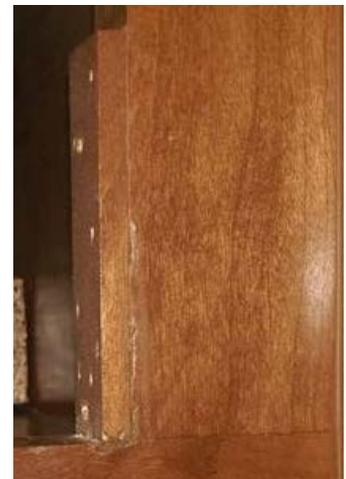
I removed the small kitchen cabinet roll-out drawer to the left of the microwave oven. The height of the drawer with its pronounced front hinders contents viewing. Additionally, removing the drawer provided more space. Unfortunately, the numerous nails used for a spacer damaged the face frame. Wood filler was used at the factory to fill the voids in the front. The rear (not visible) is split out due to nail gun overuse.

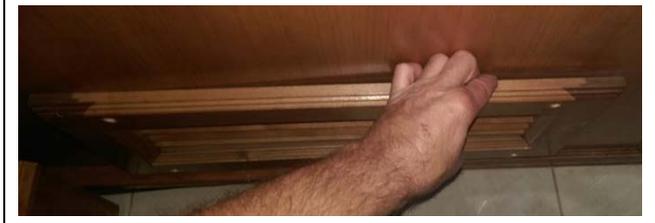
Vent under shower area had all the wood screw caps. However top fasteners were screwed into nothing. Here I am putting my fingers into a gap at the top. I removed and repositioned this vent so the 4 screws could do their job.

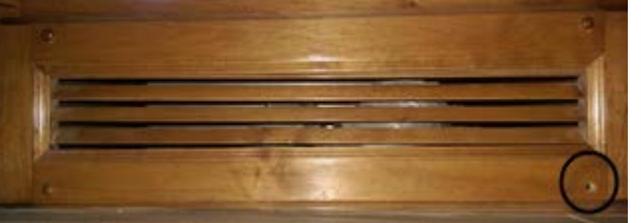
Heater vent under washer stack with the right lower corner screw cap missing.

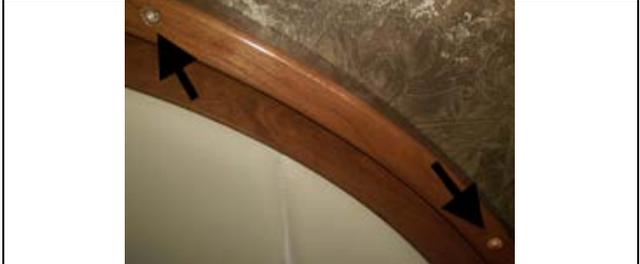
Bed headboard with missing wood screw caps.

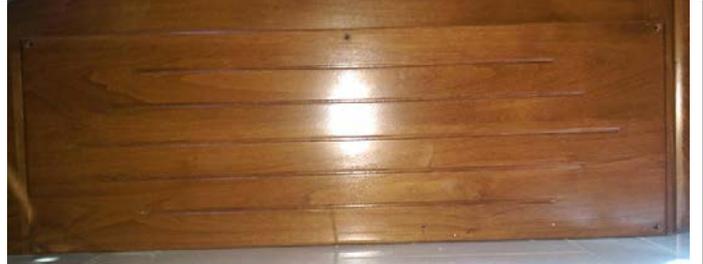
Closet base trim. Should or shouldn't there be caps? Same question for above the refrigerator?

There is considerable inconsistency in the use of the decorative wood caps normally placed over screws. Several were missing in various locations, and one vent had none at all. I will call Tiffin Parts and request two dozen. Here are some pics:

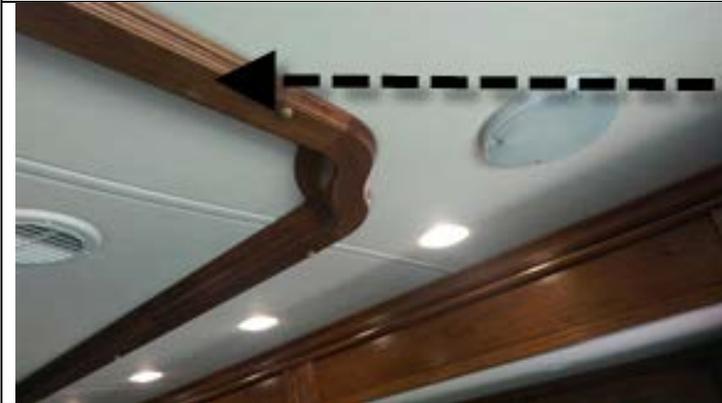
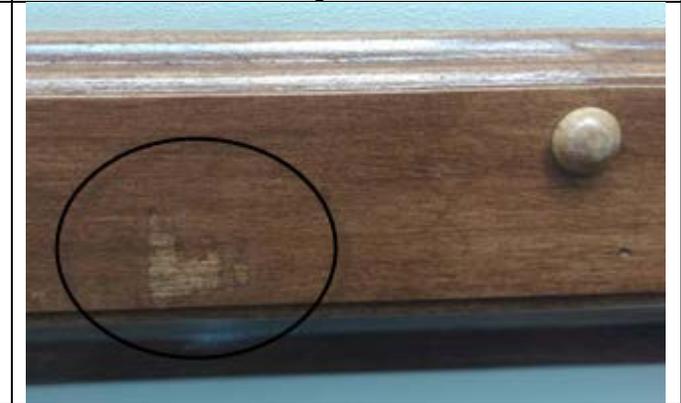
Trim with rubbed finish.

Close up view. I am going to ask Tiffin for matching wood stain.

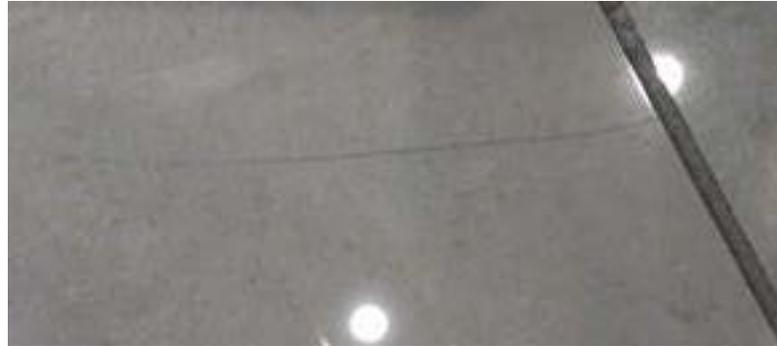
A very thin crack indeed. About 4" long. I would expect this to eventually expand to the other edge of this tile.

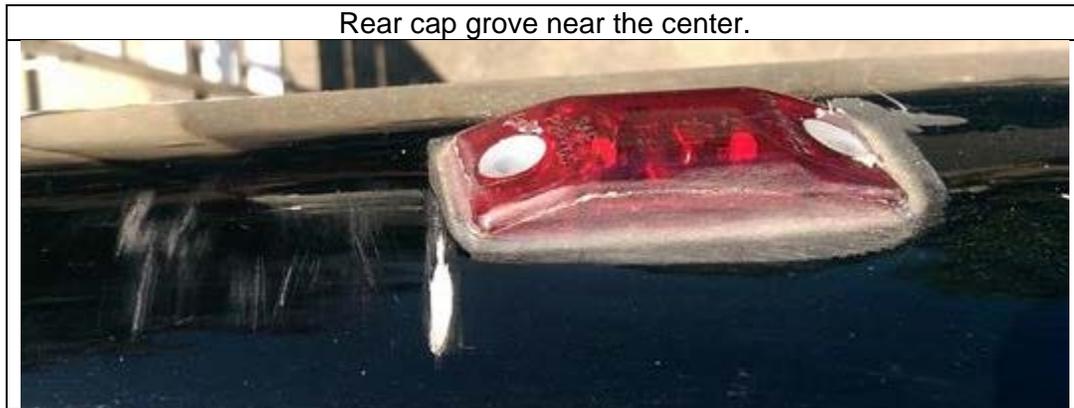
I noted the following on the roof after bringing our new rig home. It looks like a grinder or something rubbed some of the rear cap fiberglass away. In the next two photos these scratches look like someone did a layout on the roof. One of the "groves" travels parallel to the roof of the DS towards the front of the coach. Its tops near the vents where it turns inward and another continues on to the front cap. Additionally, the paint below the ladder on the right side has scratches or cracks (not shown).

Minor roof "markings" or groove near the ladder attachment points.	Additional roof "markings" scratched into the surface near the rear DS corner.

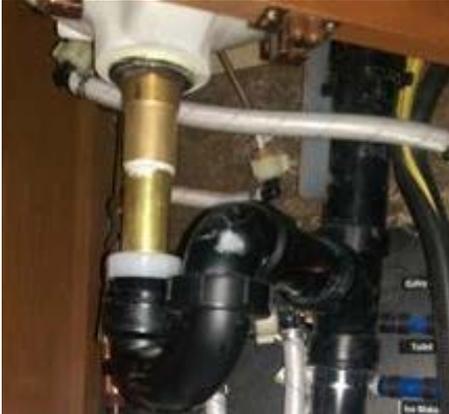
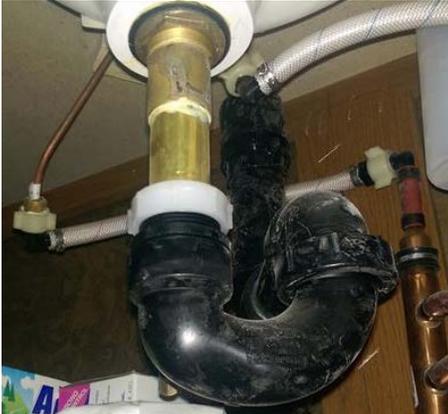
As I continue to inspect our new motorhome I am struck by inconsistencies. One noted item is the use of HepvO sanitary waterless traps in the kitchen sink, shower and laundry drains. (Thank you Tiffin). However, for the life of me, I do not understand why traditional wet traps are used at the two bathroom sinks. By using traditional wet traps one must ensure adequate water is present at these locations, or else gray holding tank smells can enter the coach. The owner's manual does not discuss the HepvO or non-HepvO locations.

Mid-bathroom sink with a wet trap.	Heater vent under washer stack with 3 out of four screw caps.

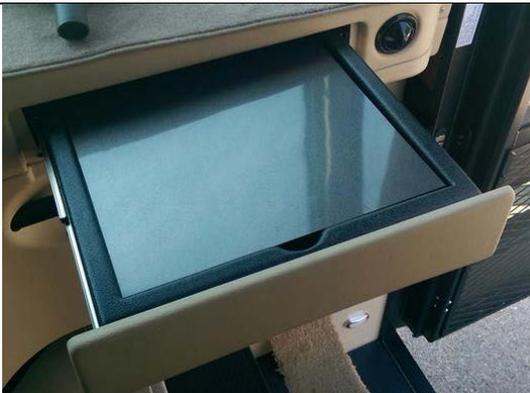
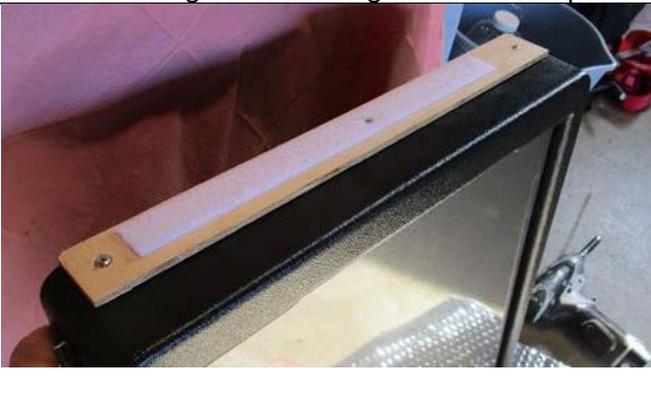
These two drawers are not secured with a latch or automatic closure sliders. The very first time we drove this RV, both front drawers would fly open at any bump. Closing the stairs drawer is a real pain from inside the coach as you must either step past the drawer or bend down to the point of falling over to close it from above. These were the very first things I "upgraded" with Velcro at the back of each drawer. Later, I will obtain "Soft Close Full Extensions" from a local cabinet shop or Amazon.

Automatic throttle governor? This drawer auto-"magically" opens each time I accelerate, and it closes when I take my foot off the throttle or slow down.	The photo shows a solution using Velcro applied to a wood spacer strip mounted on the back of the drawer. Velcro was also applied to the rear of the drawer shell. Pushing in the drawer meshes the two Velcro segments holding the drawer in place.

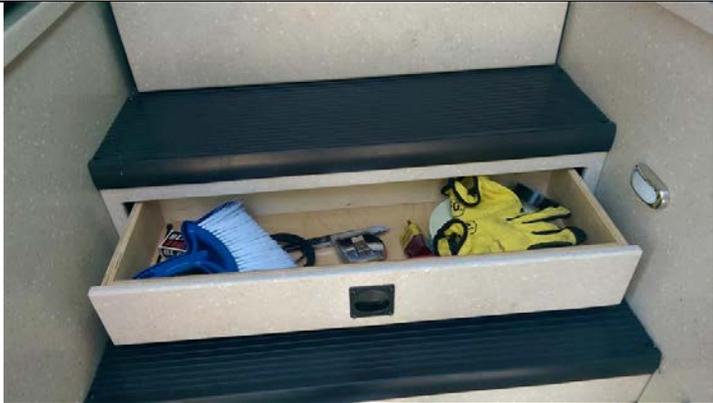
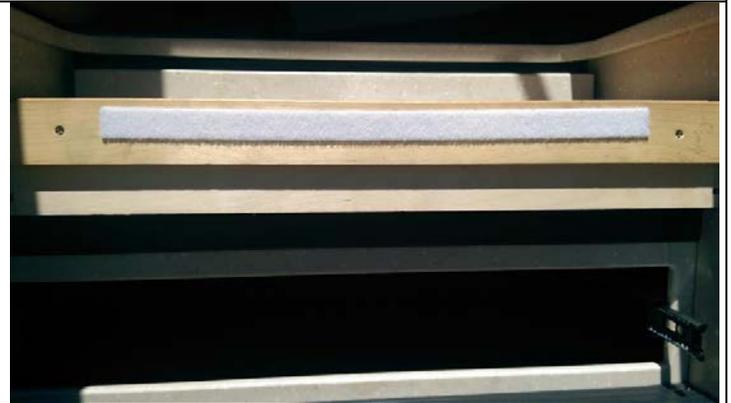
The drawer in the steps also opens randomly while driving.

A strip of 1/2" wood was attached to the drawer back to fill the void between the drawer and the rear shell. Velcro strips were then applied to the wood and the rear shell.

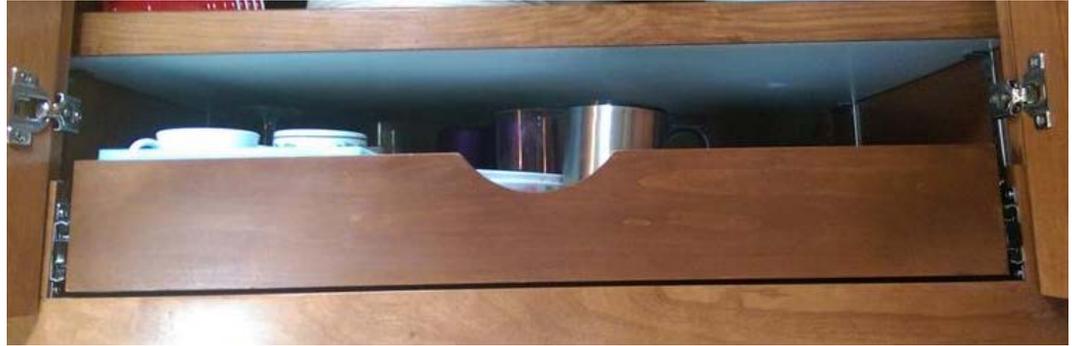
Roll-out drawers

The kitchen roll-outs above the sink are not cut with a deep enough curve so that a short person can see into them without standing on a stool. I am sure Tiffin did this to keep items from falling out when the cabinet doors are opened. A clear front plastic strip would improve this situation. As a side note: Expect to adjust cabinet door alignments and to remount/adjust shelf standards.

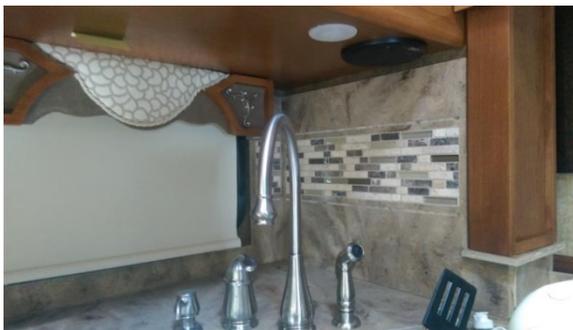
Long-neck kitchen faucet

At the kitchen sink the long-neck faucet obstructs access to the adjacent window and counter corner space. A shorter, single-hole fixture with integrated extendable spray nozzle would be cleaner than the three holes required for this fixture, and require less labor to install.

Additionally the light and speaker to the upper right of the sink prevents using this perfect location for a hanging paper towel rack. With that said, the under cabinet lighting is bright and plentiful.

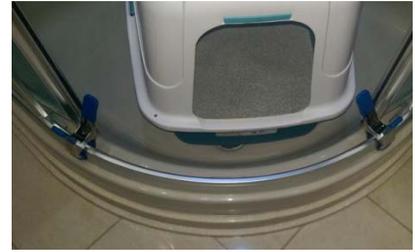
Shower doors

It would be helpful for a device to lock the shower doors open safely during travel. This would allow travel with a cat box in the shower enclosure.

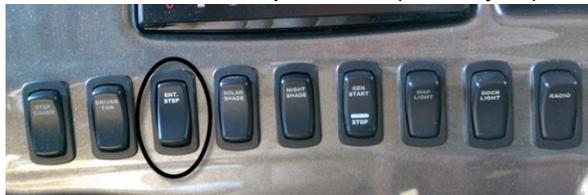
The Phaeton owner's manual states on page 9-5, item 4, that the steps can be locked in a retracted position. I found this does not work. Additionally, Tiffin Service at Red Bay told me the manual is incorrect. This is also counter to the Power Step 875 manual. I can lock the steps in an extended position without issue, but I need to lock them in, so I can park close to street curbs. Otherwise when I dump the air bags to level the coach, I could damage the steps or the coach.

In the TRVN forum I found discussion threads on this issue but no clean solution. I called Tiffin parts and they sent me another step switch (thank you), which I wired in-line with the door jamb step switch.

Installing my own override switch was facilitated by a firewall plug that allowed me to pass a new wiring harness into the driver's side under-dash area. I installed this second step switch in a spare dash switch location. Now I can drive and park with the confidence of being able to lock the steps in.

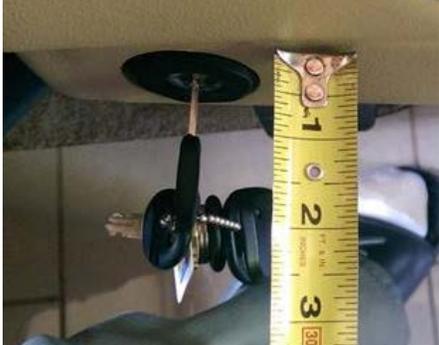
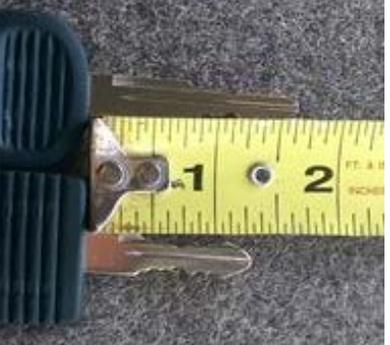
I am rather short at 5' 7". This requires me to bring the seat forward. In doing so, the driving position places my knee near the ignition switch. Making matters worse is the rather long key with a half inch of wasted length. If I had my way, the ignition switch would be relocated. I have nearly broken the ignition key off when sliding into the driver's seat, when I failed to remove it beforehand. As a compromise, I had shorter keys made at my local locksmith shop for \$5.

Original key extends over 2" from dash board	Cut-down key is about 3/8" shorter.

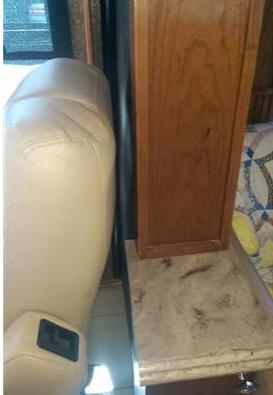
The new Flexsteel seats with integrated seatbelts are nice looking and functionally better than the old seats with detached seatbelts that extended to the coach walls. Unfortunately, the “one size fits all seats” are made for larger occupants. The tall seatbacks also limit the passenger seat recline angle due to the near proximity of the PS slide-out. The recessed center section provides no lower back support. Additionally, the seatbelt cuts into the side of your neck since, like the seats, they were designed for a larger physique.

Close proximity of the passenger seat to the slide-out. The seat position is full forward. While it is difficult to see in these pictures, there is little to no recline space available.	Tall seat. Due to seatback height issues and seatbelt neck pinch, my wife uses pillows to sit on and support her back. Inquiries about having the seats modified have so far failed.

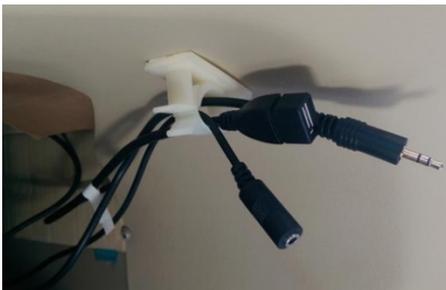
1. iPod/iPod audio input(s) and USB cables not installed requiring radio removal.
2. No convenient dashboard location for the iPod/iPod audio input(s) and USB cables.
3. The “Bluetooth” microphone was plugged into the wrong connection port on the back of the radio.
4. Directly below the radio is a Tiffin-installed USB charging receptacle. Why doesn't Tiffin use the radio to feed this USB port with an added 3.5mm audio port? The alternative now is forcing us to create our own connection ports in the dash or let the cables lie on the floor.
5. Why doesn't Tiffin wire in a roof top camera to the unused video input on the radio or to the camera monitor system? This would allow us to see low hanging branches.

Temporary owner-installed connections to radio for iPod use.

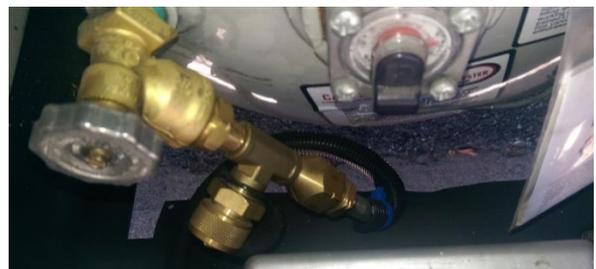
While propane usage has not been a concern in the past, I wanted to install a three-way adapter on the propane tank for my external BBQ and an external auxiliary propane tank, if needed. However, space is limited in proximity to the propane tank outlet. The best solution would be a Tiffin installed assembly for BBQs. Lacking that, allowing more space for such a connection adapter would be helpful.
