On July 1st, 2014, my wife and I took delivery of a new 2014 Phaeton QBH. Our purchase was delayed from May 2014 while the dealer repaired chipped tiles in the rear bathroom around the engine cover hatch. As of September 1st, 2014, we had yet to take our maiden trip due to family commitments and as we continued “outfitting” and correcting concerns with our new coach.

This is a collection of observations, concerns and enhancements since the July 1st delivery. I am writing this for my records, and to send to our dealer and Tiffin. Additionally I will post a copy on the Tiffin RV Network (TRVN) web site at <http://www.tiffinrvnetwork.com> as this information may be useful to others. My thanks to the wonderful TRVN members for their countless ideas and information. Your knowledge sharing greatly aided our new ownership learning curve. While we expected to incur new rig issues, I have been surprised by the amount of time required to prepare our land yacht for launch. I am also pleased that the issues we have encountered are rather benign.

Note: Since I did not publish this paper before our Sept 9th trip, I have added an additional section at the end of this paper entitled Updates and

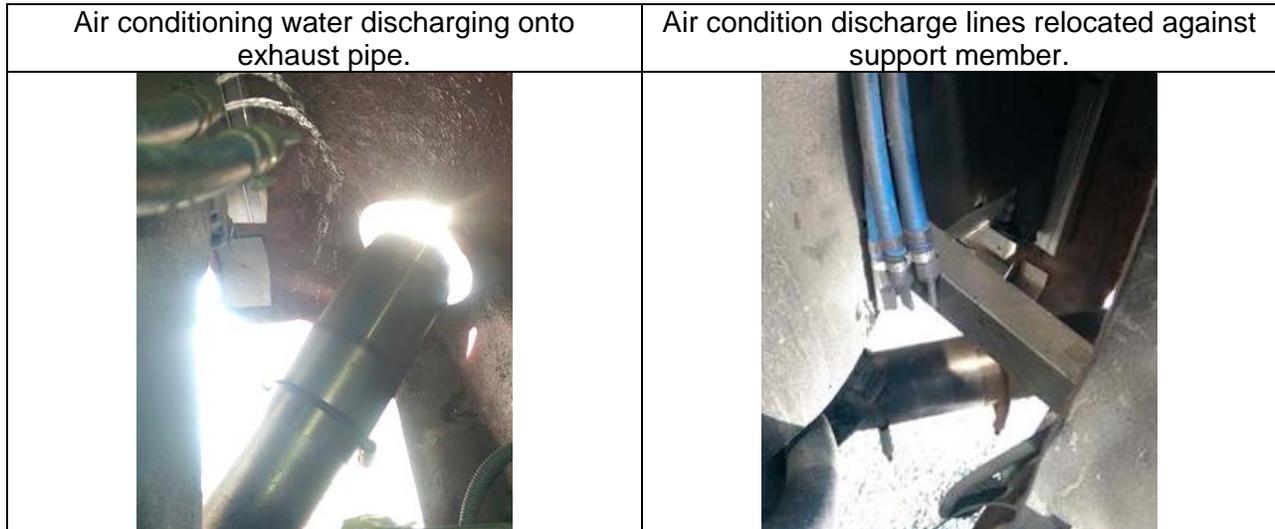
The air conditioning drip lines discharge directly onto the exhaust pipe adjacent to where it vents to the rear of the coach. While I am no expert, water and metal are not a good mix. Even when the exhaust system is cold, discharging the water onto the pipe and clamping bolts will only lead to corrosion. For the present time, I have relocated the discharge tube against a rear support member, allowing the ac discharge to fall to the ground.

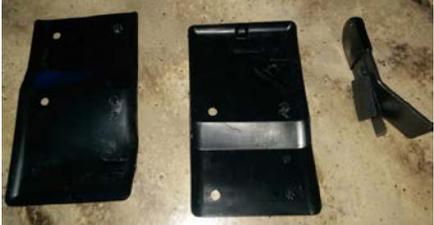
Misc parts found under the front cabin bed.	Broken HDMI cable.

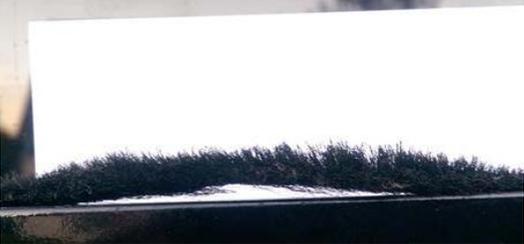
Frayed window weather-stripping on one window in various places on the bottom edge.	Dead LED ceiling light (center bulb).

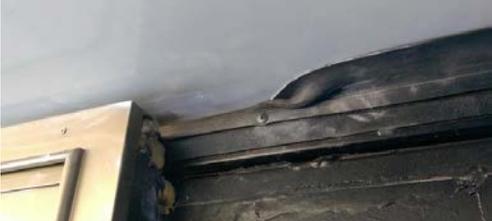
DS lower slide-out gasket is stuck/caught such that it does not fully deploy.

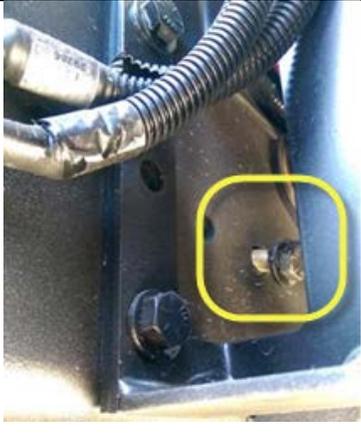
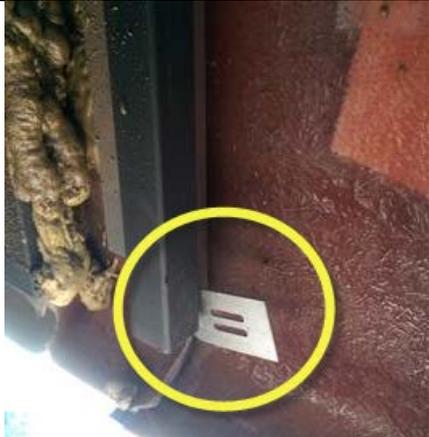
In preparation I performed a safety inspection and found an unsecured frame bolt adjacent to the generator/steering box, and discovered that the mid-span turn signal lights (in front of the rear tires) were wired backwards. Either of these two items, if noted by the DMV official during the vehicle safety inspection would disqualify me from advancing to the next licensing step until they were corrected. Since I had less than 20 hours before my DMV appointment, I called Tiffin and Freightliner. Freightliner advised the mid-span turn indicators were a Tiffin (coach) responsibility. As for Tiffin, I waited in the service department phone queue for what seems like hours, but was only 30 minutes before I selected the option to leave a voicemail callback message. Unfortunately, upon selecting this option, I was disconnected...Gotta love phone trees.

<p>Is this grade-8 bolt falling out for a reason? Located just in front of the steering box, under the driver's seat. A lose bolt like this would have failed the DMV safety inspection.</p>	<p>Metal support for the front DS fiberglass front-end under the headlight There is no evidence of this metal bracket holding anything. Wish I knew someone with a Phaeton that I could check.</p>

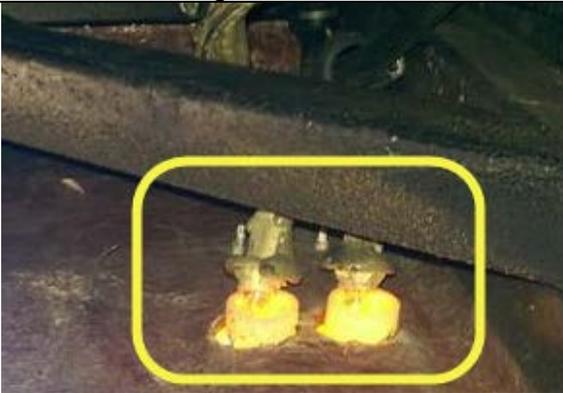
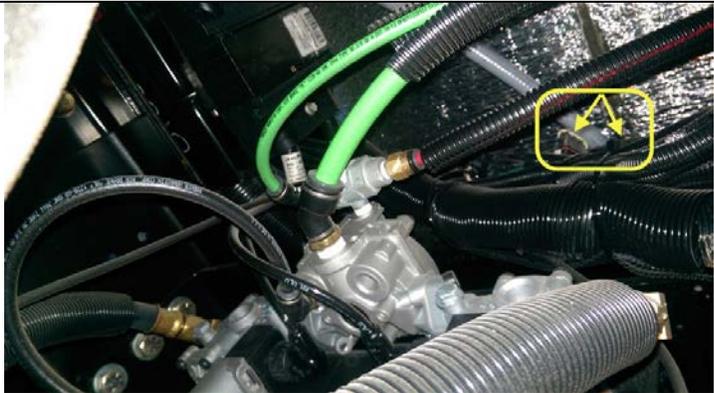
<p>This is how I found the DS mid-span marker lights. I had to remove undercoating foam just to plug them in, only to learn the turn signal wiring was incorrect.</p>	<p>The mid-span marker light connectors are above, near the reflective floor insulation, far out of reach.</p>

I parked the rear passenger wheels on the raised road curb to obtain enough clearance to crawl under and locate the incorrect connections. I found them bundled up and tie wrapped in a most inaccessible location atop a frame member above the rear air brake system. There was no way I would be able to directly reach the connectors. I tried every imaginable idea including hooks on sticks, two-foot long needle nose pliers, wiring snakes and will-power. I tried repeatedly. It was nearing 3PM when I gave up trying to do the right thing and made a cross connect harness to patch the turn signal lights to the wiring on the other side of the coach. Thirty minutes later I was done.

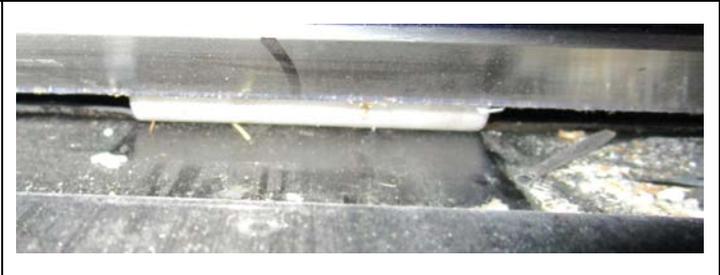
A difficult to photograph tile blemish that repeats adjacent to each DS slide-out roller.	Picture of a DS slide-out roller showing the debris (metal, dirt, sawdust, wiring discards, etc. Is this debris destroying the tile finish?

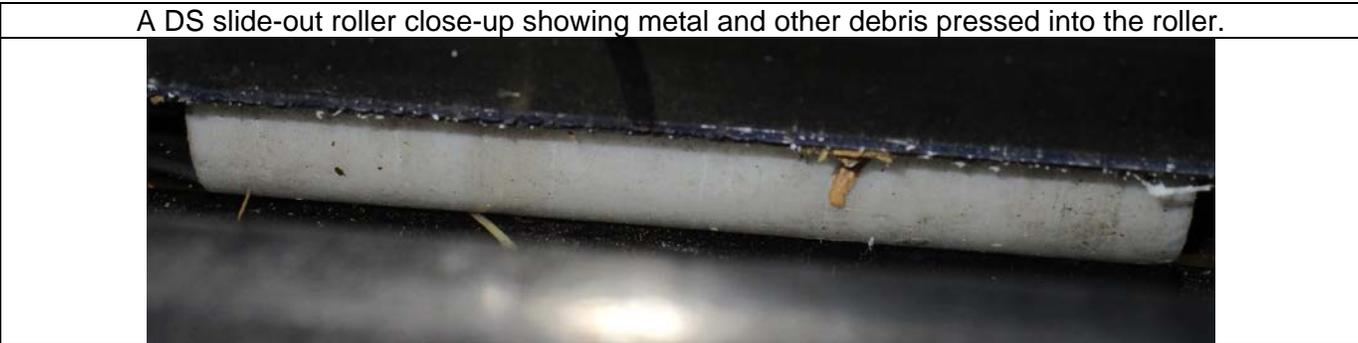
Front edge under the DS slide-out showing leftover construction materials and a raised screw lifting the slide-out leading edge by the driver's seat. This screw explains part of the air and light leak at this location as it has pushed the plastic edging material and carpet up off of the floor. Doesn't anyone check at the factory?

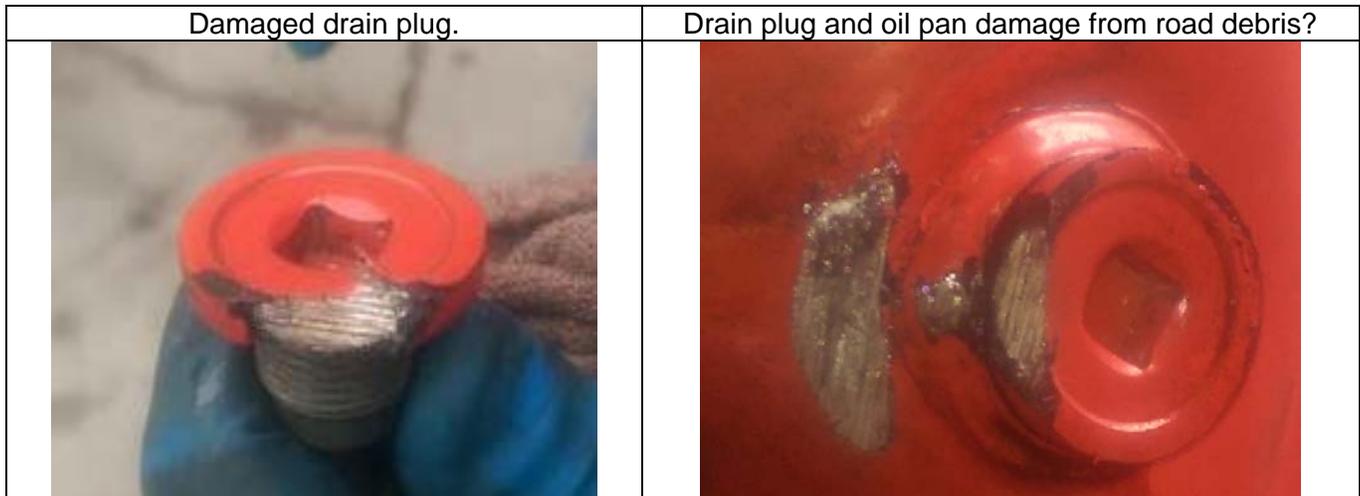
See the picture below and you will understand the oil pan R&R. No other marks or damage anywhere else on the bottom of the rig, frame members, etc. Unfortunately, the impact was strong enough to create a crack that wasn't leaking yet, but just to make sure... Even with the Cummins warranty paying for the oil pan repairs; it still cost me over \$400. Warranties do not cover the fluids such as oil and the routine maintenance items such as the oil and fuel filters.

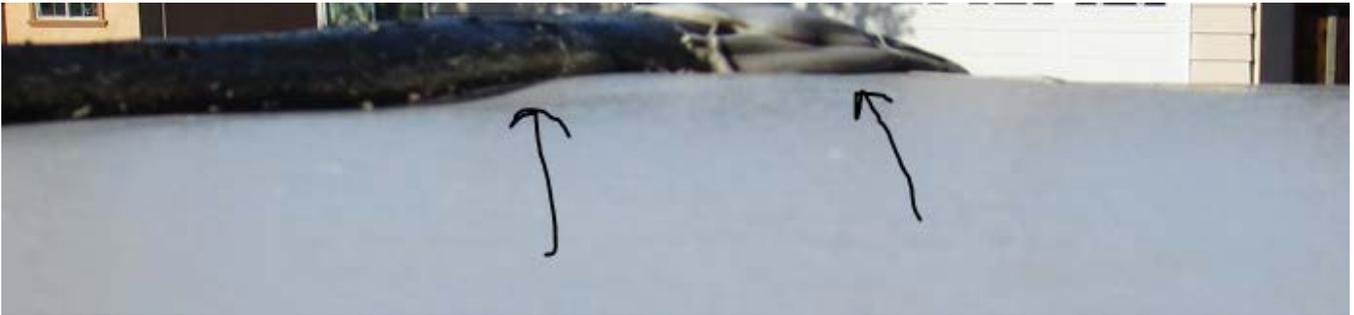
Today's clear skies and warm weather allowed me to inspect the roof and take updated photos of the "scratches" that run across the rear from the ladder area to the driver's side, then along the left roof area to the front cap. Unfortunately, while conducting my inspection I noticed two roof areas with bubbles, possibly delamination or separation of the fiberglass roof top coat from the wood sub roof. While these areas are rather small, they could be the start of something bigger. Regardless, they need to be documented for warranty support and inspected by someone that knows what to look for. Since I am taking the RV in for coach repairs next week, I sent an email with supporting pictures to our Tiffin factory representative.

This following picture shows a valley in the roof area adjacent to the rear cap on the left and a spongy bulge denoted by the arrows. The bubble height is about half an inch.

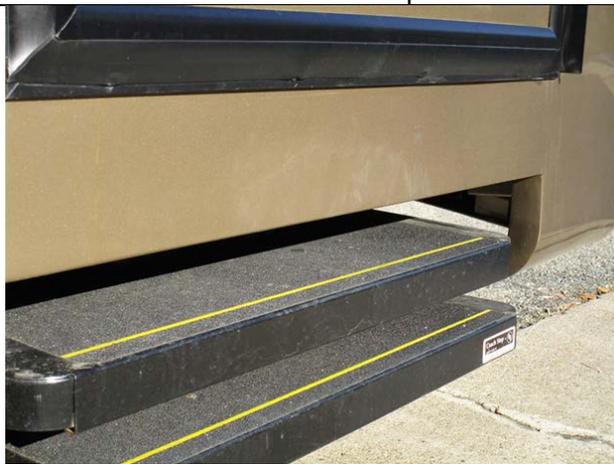
Today, while taking slide-out roller photos for adjustments (see the discussion in the following section), the entry steps folded inward when I stepped on them. Afterwards, the steps would not move on their own and made a gear grinding noise until I turned them off. The following photo was taken after I pushed them in to a near stowed position. Since I am taking our RV to Leale's for service next week, I again sent an email with supporting pictures to Phillip, our Tiffin factory representative, requesting warranty repair authorization.

Dead steps after they collapsed. Almost took a header on the steps.

For safety reasons I will tie the steps in this stowed position for travel as they can extend on their own.

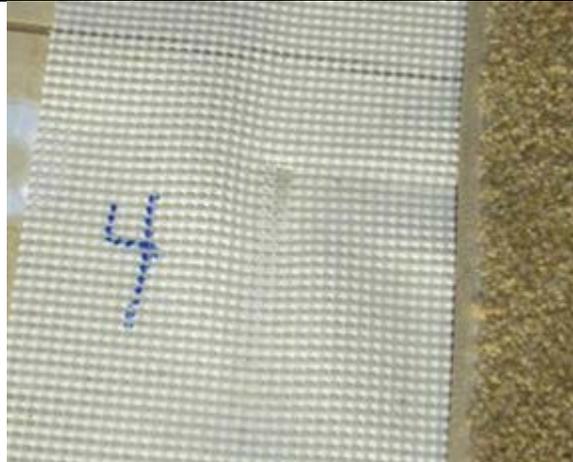
Front roller indentation behind the driver's seat. This rather thick shelf matting protects the tile and provides a visual gauge for roller loading.	Middle roller (4 of 8) showing small contact area. Rollers 7 & 8 showed no contact even though they are adjacent to the heavy refrigerator.

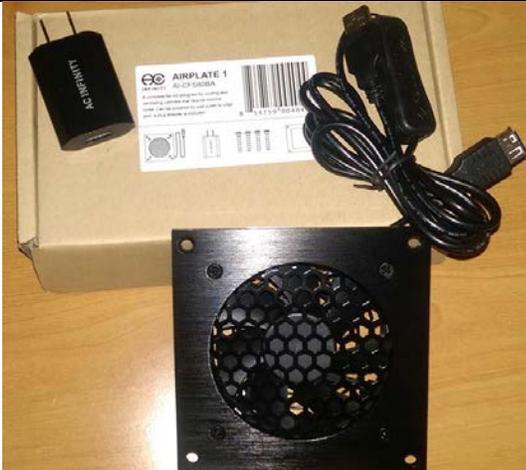
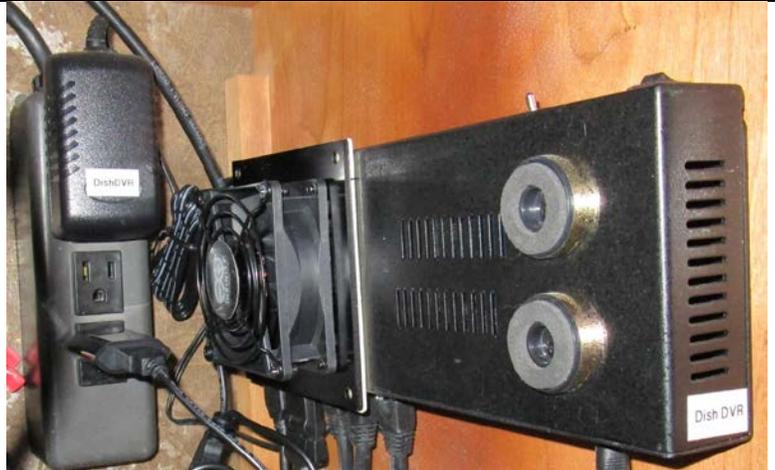
Previously, I wrote about the TV electronics cabinet in the top of the bedroom dresser. Since reworking this area I felt the HDMI spitter/distribution box still operates at too high of a temperature to ensure a long useful life. I have since added an Infinity AI-CFS80BA Single 80mm silent fan I obtained from Amazon

New low speed silent fan, about \$17 from Amazon.	Fan mounted to HDMI splitter/distribution box with double sided tape. Air direction blows air into HDMI box.

This silent fan operates on a low DC voltage typical of the USB voltage standards now common. It also comes with a small AC to USB DC converter that uses USB connectors, allowing one to connect multiple fans to the common AC adapter or to a USB port on the Blue-Ray player or a Dish/DirecTV receiver. So with a little double sided tape I attached the fan directly to the HDMI box that now operates considerably cooler. I have not added a fan to the HDMI splitter for the Blue-Ray unit as I rarely turn it on.

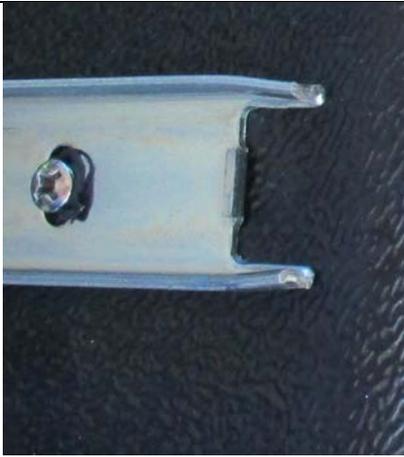
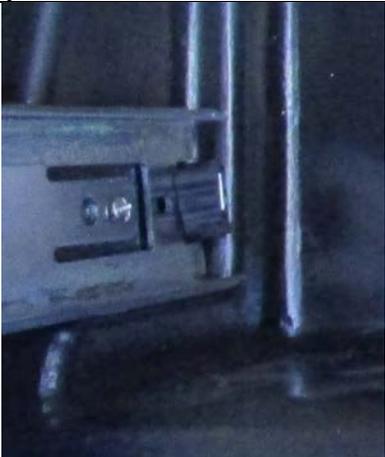
Drawer mounted rail with protruding jaws	Cabinet mounted half of the slider that must fit into the jaws on the drawer mounted rail.

Previously I wrote about putting Velcro on the back of these drawers to keep them in a closed position when the RV is in motion. During Phillip’s visit he explained how correctly adjusted slide rails should prevent the drawers from opening.

Using calipers, I estimated the correct mounting points, which varied from side to side of the drawers as the cabinet hardware was mounted at different depths from the cabinet face. Now there are more unused holes in the sides of the drawers. But the catches in combination with the Velcro provide a secured drawer.

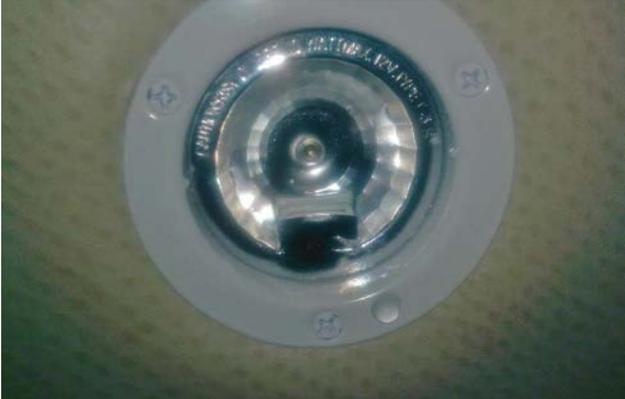
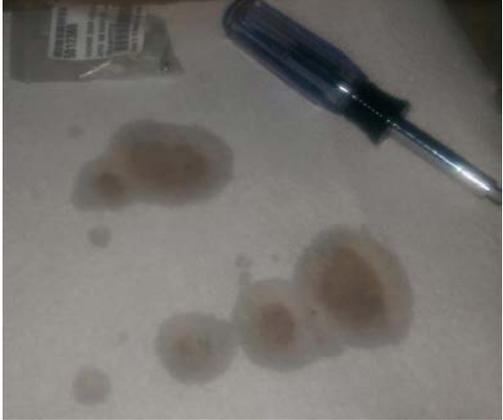
Replacing an LED is easy, as Phillips had shown me how. Just rotate the glass lens and pull out the LED array, then put in the new one. Ok - simple, except when you get wet doing so. The lens was full of water. There was a little on the floor, but it wasn’t noticeable until I looked for it. Upon removing the ceiling light fixture (3 little screws) I found myself looking at coax lines for the antenna directly above and the bottom of the fiberglass roof. I had not considered that the light fixtures were covering roof access points. Now I know. Unfortunately, in my wisdom of parking the RV unlevelled, to provide rain run-off to the side, it allowed the penetrating rain to follow the coax cables to the down-hill side of the insulation passage, where it could run towards the passenger sidewalls. So, I have no idea of how bad the leak is and how much water got into the coach. I just emailed Phillip. Another repair to add to the list.

Wet ceiling light fixture.	Rain water from the ceiling shown on a paper towel.

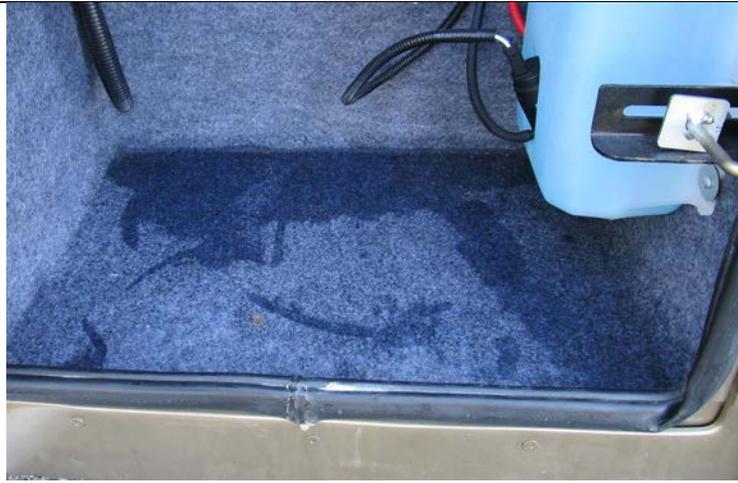
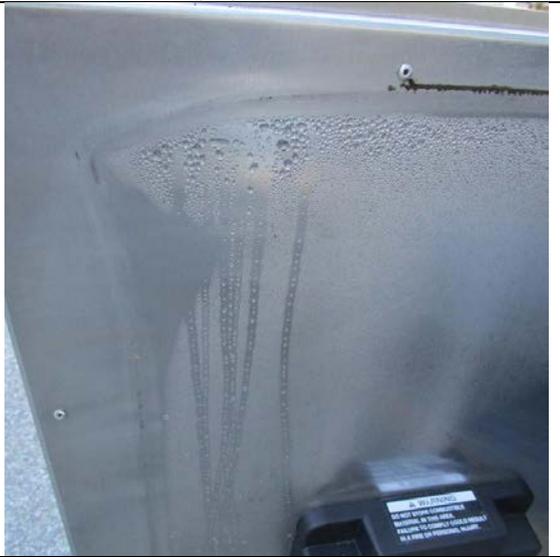
We are catching water in the basement compartment under the driver's seat. When Phillip visited he inspected this feature showing me that the door latch was only catching on the first, not the second latch point. In addition to adjusting the latches, the door need an alignment adjustment as it protrudes at the top where the top of the door acts as a water catch basin.

Wet ceiling light fixture.	Rain water from the ceiling shown on a paper towel.
